## **REPORT OF MARINE SURVEY**

**Pre-Purchase Condition & Value.**

**"Ricochet"**

**2006 Grady White 330 Express**

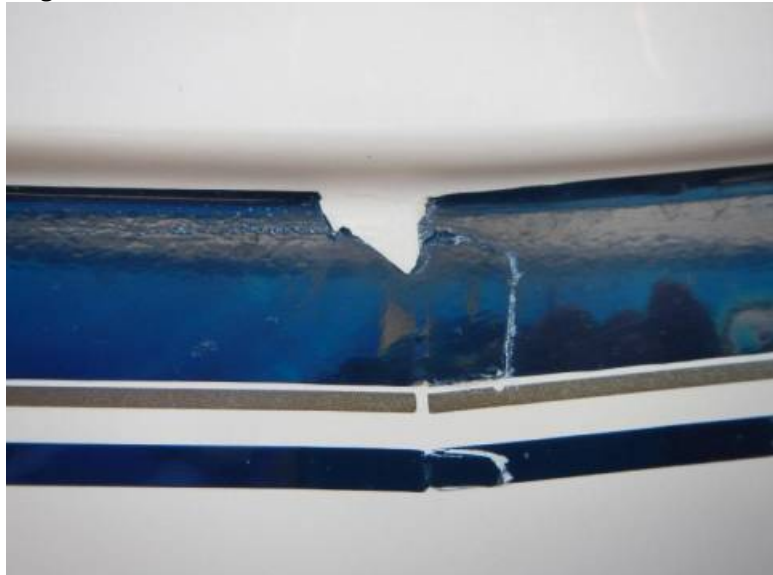
**Hull Cosmetics:**

Hull cosmetics are in good condition-minor nicks and scratches. Vinyl stripe damage on the starboard side.

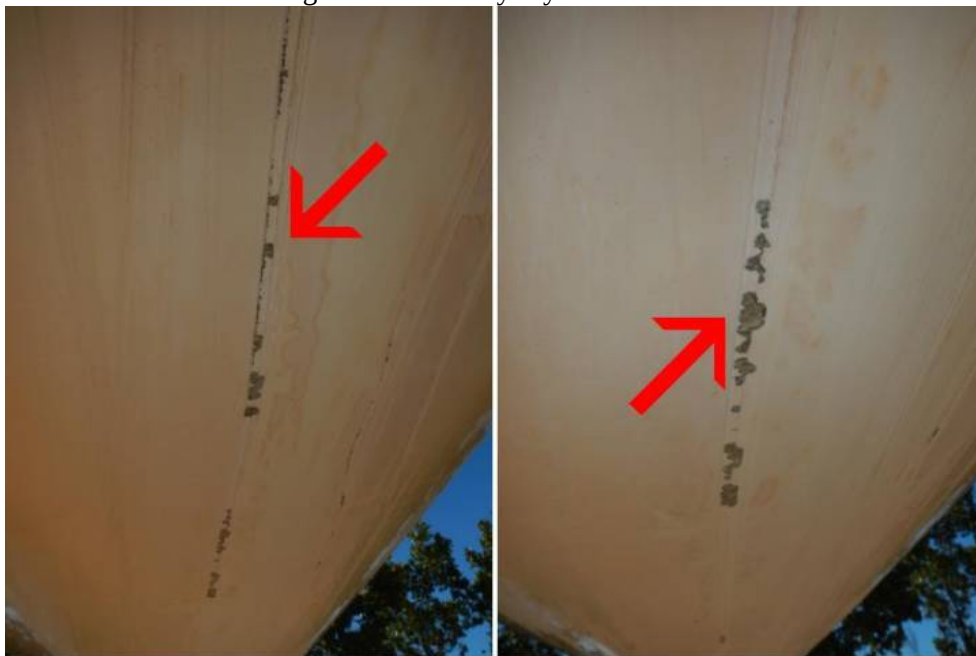
**Grounding damage:**

Grounding damage sighted below the stem running aft approximately 3 feet in length. Gelcoat is gone and exposed fiberglass is visible.

| Findings: | Recommendations: |
|---|---|
| Slight grounding damage on the bottom. | Have a qualified fiberglass technician repair gelcoat |

*Findings:* Slight grounding damage on the bottom.

damage.

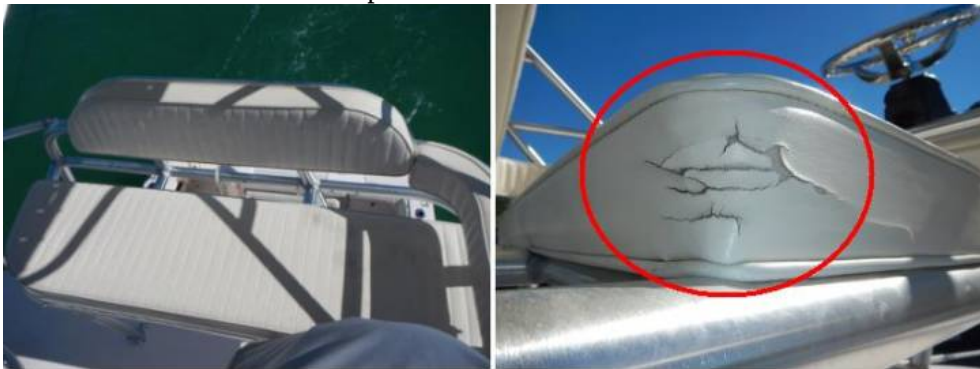
Seating:

Large bench seat. Corner of the bench on the starboard side has cracked vinyl.  
Good Condition.

| Flybridge bench seat has cracked vinyl. | Have upholstery technician repair cracks. |

*Findings:* Flybridge bench seat has cracked vinyl.

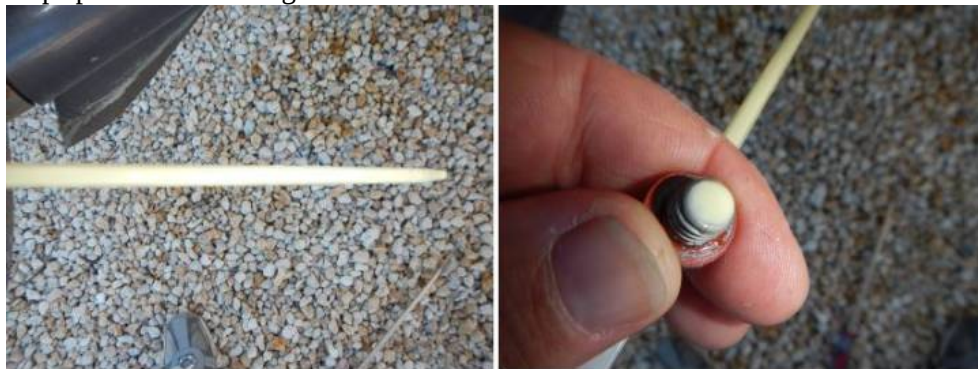
**Lube Oil Condition:**

Port: Lower unit oil so low unable to get a reading when checked.

Starboard: Lower unit oil is milky in color indicating contaminated with water.

**RECOMMENDATION:** Seals or O-rings may be deteriorated. Have the drive pressure and vacuum tested by a qualified outdrive mechanic to determine if seals are leaking and the source of water intrusion. Repair as necessary.

*Recommendations:* Seals or O-rings may be deteriorated. Have the drive pressure and vacuum tested by a qualified outdrive mechanic to determine if seals are leaking and the source of water intrusion. Repair as necessary.

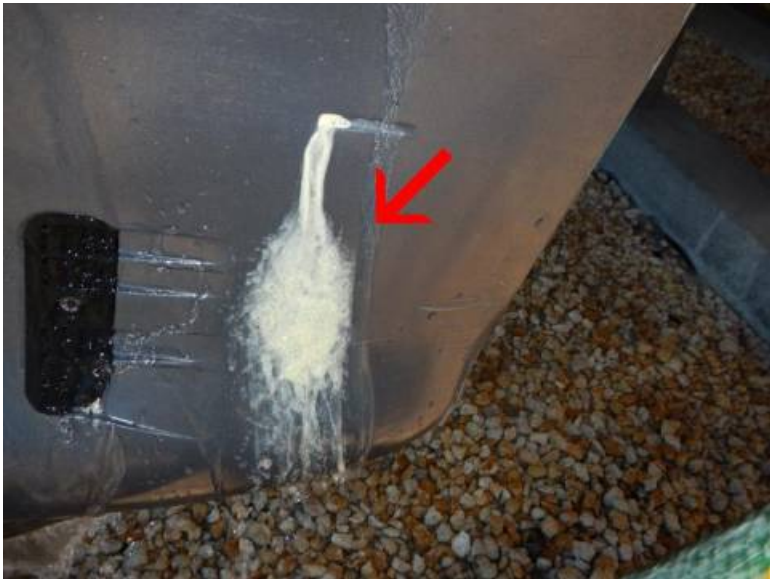
Starboard engine running while on fresh water flush out. Milky lower unit oil is seeping out of the unit.

| Findings: | Recommendations: |
|---|---|
| Lower unit oil so low unable to get a reading when checked. Lower unit oil is milky in color indicating contaminated with water. | Seals or O-rings may be deteriorated. Have the drive pressure and vacuum tested by a qualified outdrive mechanic to determine if seals are leaking and the source of water intrusion. Repair as necessary. |

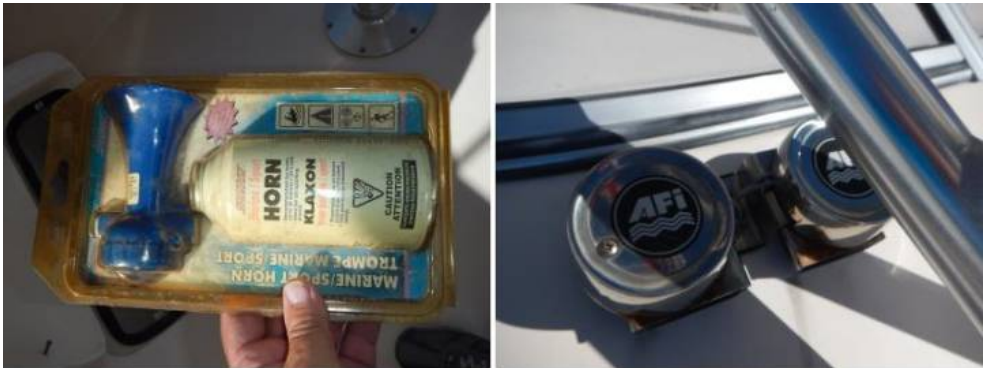
**Sound Devices:**

Electric horn is functional. Hand held air horn is available.  
No placards sighted for oil or garbage. These are required for any vessel 26' or longer. RECOMMENDATION: To avoid a potential large fine, install a USCG "No Discharge of Oil" placard in or near engine space to comply with - 33 CFR 155.450 and post a trash disposal placard near the waste area to comply with USCG 33 CFR 151.59.

*Recommendations:* To avoid a potential large fine, install a USCG "No Discharge of Oil" placard in or near engine space to comply with - 33 CFR 155.450 and post a trash disposal placard near the waste area to comply with USCG 33 CFR 151.59.
