| SHIP NAME | APL POLAND |
| DWG. NO. | MA8-LA2007F |

## MITSUBISHI SERVICE INFORMATION INDEX FOR MITSUBISHI-SULZER RT-flex96C DIESEL ENGINE

# S.No.2228

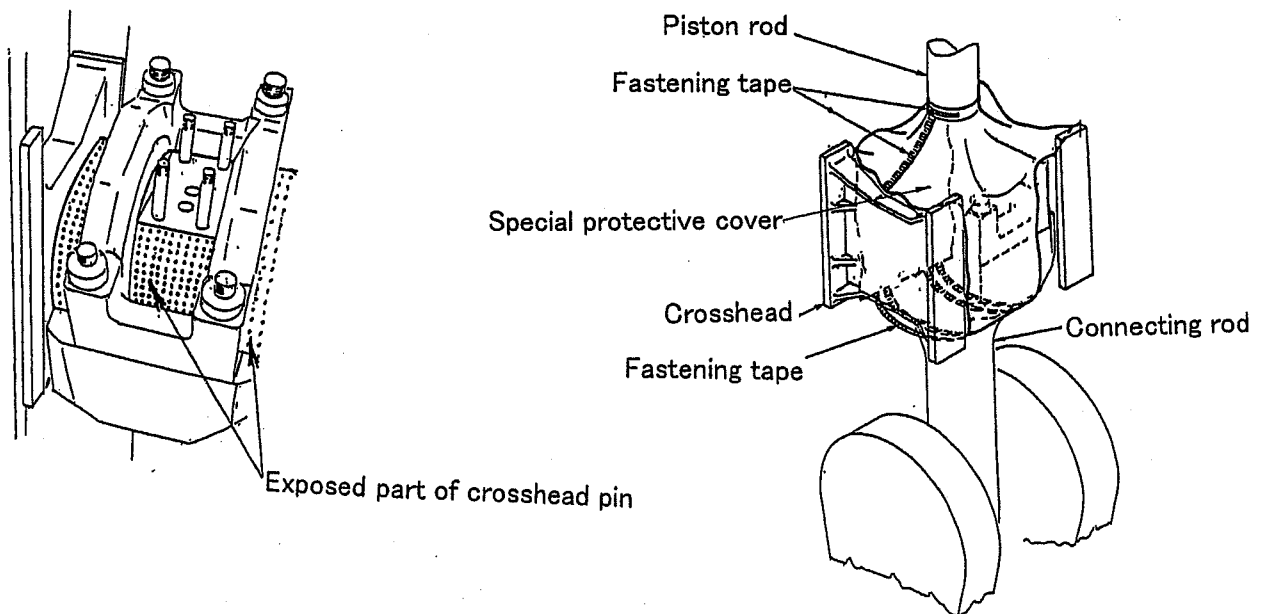
It has been reported that crosshead bearing and pin were damaged because sludge, dust, etc. entered at the crosshead bearing upper part when overhauling the piston or the stuffing box without piston extraction.

The crosshead pin is widely exposed at its upper part, and if sludge and dust enter those parts, they might damage the bearing metal or the crosshead pin and might bring about the peeling-off of the bearing metal in the worst case.

Therefore, it is recommended to take measures for preventing dust from entering when the above work is carried out over the crosshead bearing.

In addition, when overhauling the stuffing box, you are kindly requested to carry out the cleaning of piston under side space surely before the overhaul.

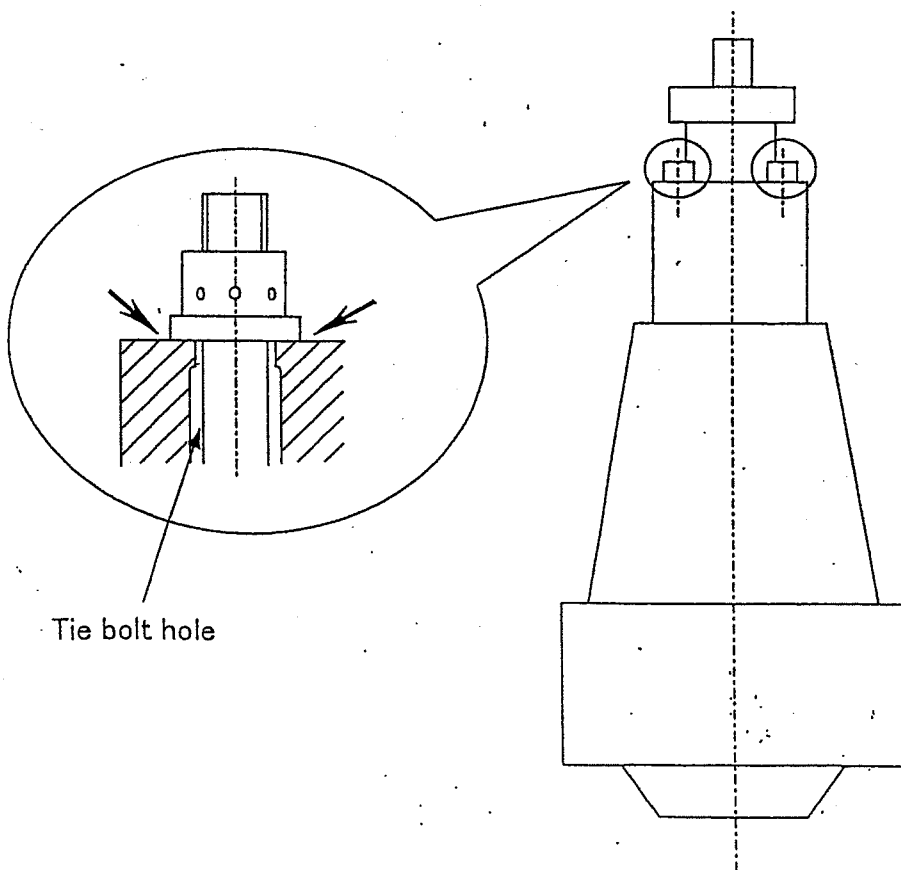
Tie bolt hole

It is thought that water or corrosive liquid might introduce tie bolt holes while maintenance work is carried out in dock or on board and it makes tie bolt threads or the tie bolt hole inside for the tie bolt corrode in some cases.

It is presumed that admitting water or corrosive liquid into tie bolt holes might lead to a serious problem due to the corrosion.

Therefore, when the repair work in dock or maintenance work on board is carried out, you are kindly requested to take care to prevent water or corrosive liquid from entering the tie bolt holes.

If, accidentally, water or corrosive liquid enters into the bolt holes, drain it off immediately.

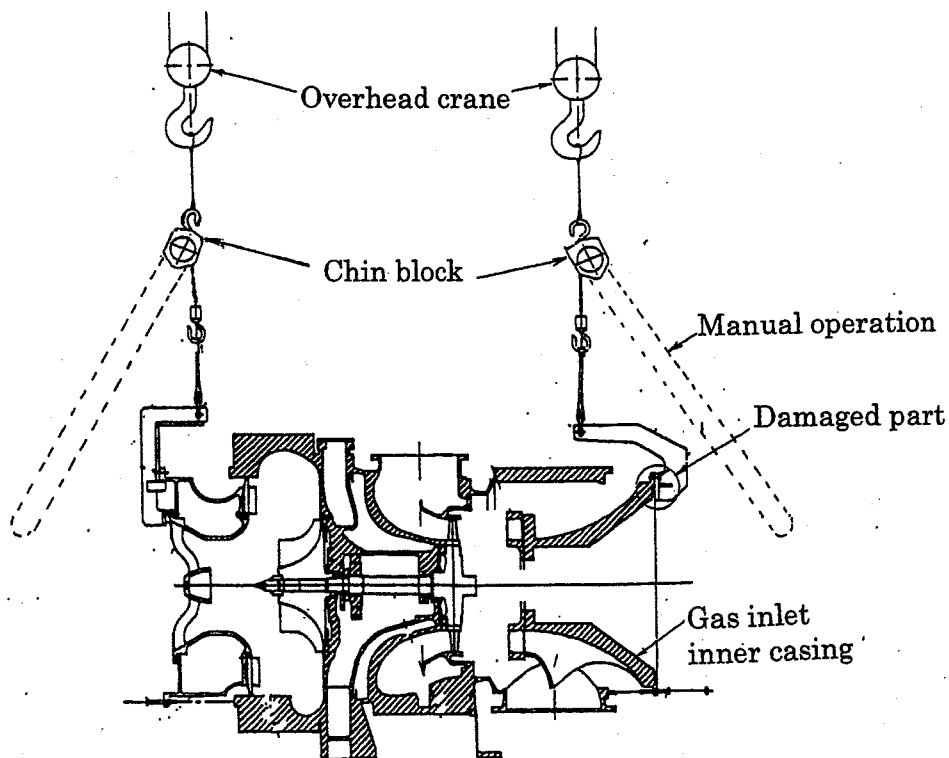
It has been reported that when the turbocharger was overhauled, the gas inlet inner casing was damaged at the flange part by an inappropriate dismantling work.

When the proper dismantling tool was fitted and directly connected to the overhead crane and then the gas inlet inner casing was pulled out while it was lifting up, the flange of the inner casing was damaged due to the fact that excessive force worked suddenly at the flange since fine adjustment could not be carried out for lifting up the inner casing.

In the same way, lifting-up and lifting-down work of dismantling and assembling parts needing small force and fine adjustment is not to be carried out by the overhead crane directly and the work is to be carried out by the condition that a chain block is connected between the overhead crane and the dismantling part and the chain block is manually operated.

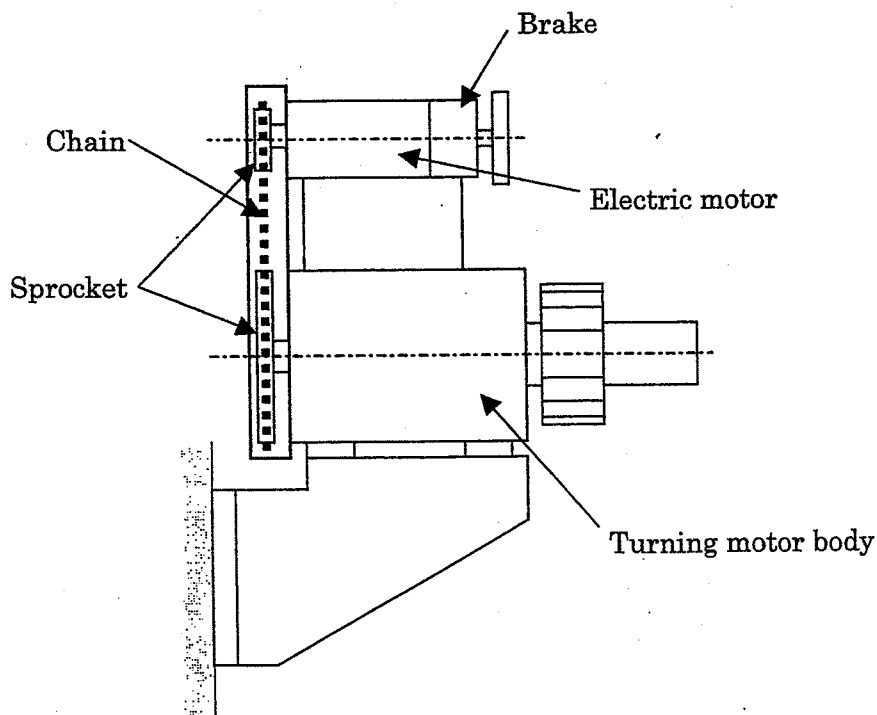
Recently, it has been reported that sprockets and/or chains of the main engine turning gear were worn after more than 15 years operation from her commission, though the periodic inspection for the lube oil level is recommended in the "Engine Maintenance Manual."

Such wear for turning gear transmitting mechanism and/or the wear for brake of electric motor may be in danger of human accident, and therefore, such parts have to be replaced with sound ones immediately if the said wear is revealed.

In this regard, it is strongly recommended to carry out the periodic inspection to the transmitting mechanism/safety mechanism of the engine turning gear device including the electric motor as well as an inspection for the oil level, especially to engines that have longer running hours, to avoid any possible human accident due to such wear mentioned above.

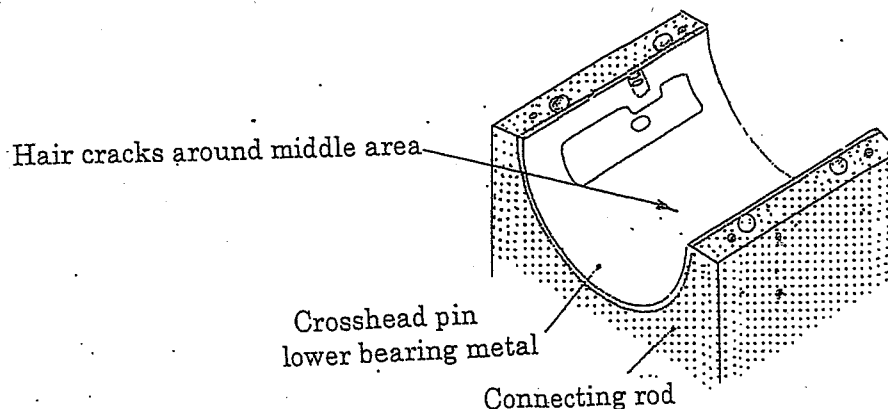
This recommendation as above has been made from the service condition that hair cracks occurred around the middle area on the white metal in some service ships which experienced for a long time service hours since delivery.

When the hair crack is found out on the area in question at the periodic overhaul inspection by any chance, since the crack will progress though the propagation is slow, we would like to ask you to renew the bearing metal by catching an opportunity. Furthermore, if white metal separation is found on the bearing metal, it has to be early replaced and we recommend replacing the bearing metal at the opportunity as soon as the ship's schedule allows.

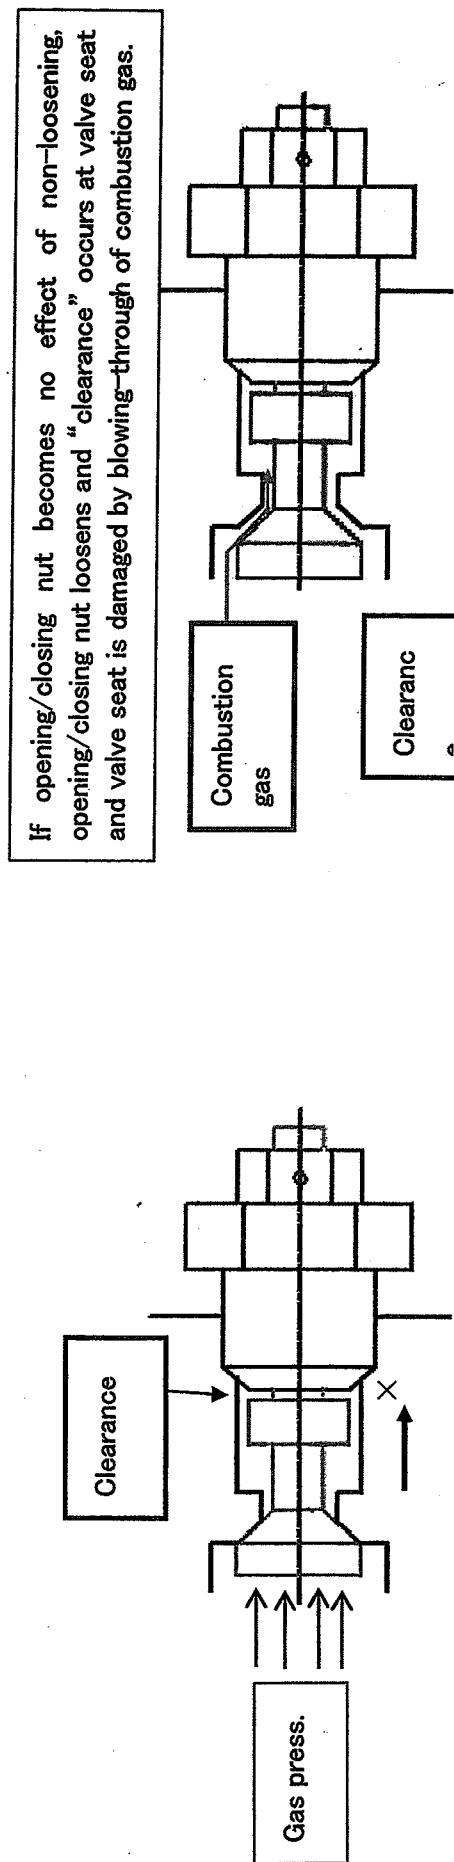
In the case that U-nut has been loosened and a clearance has occurred between opening/closing nut:

Since "clearance" occurs on trouble parts of poor tightening, gas pressure does not work to opening/closing nut and effect of non-loosening of U-nut is reduced.

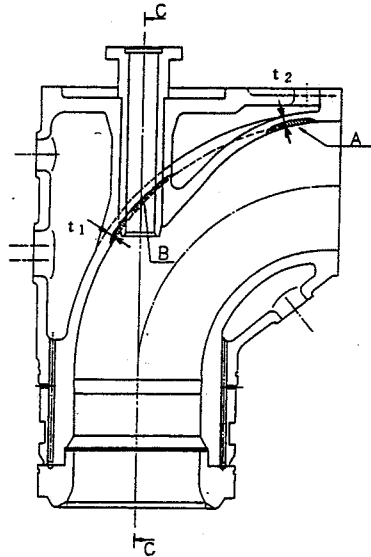
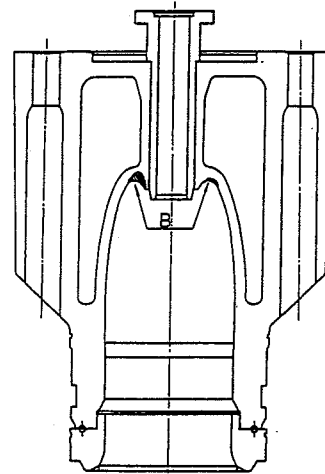
SECTION C-C

The allowable depth of the corrosion is to be not more than half of thickness and the repair by welding shall be made in case the depth exceeds the above limit. (The under-mentioned table is to be referred to for the designed thickness of each engine model.)

Remark: The corrosion on "B" part is remarkable due to swirling at the stern side.

We would like to recommend you to place a repair order with our company because the repair work needs a special technique due to the material of cast iron.

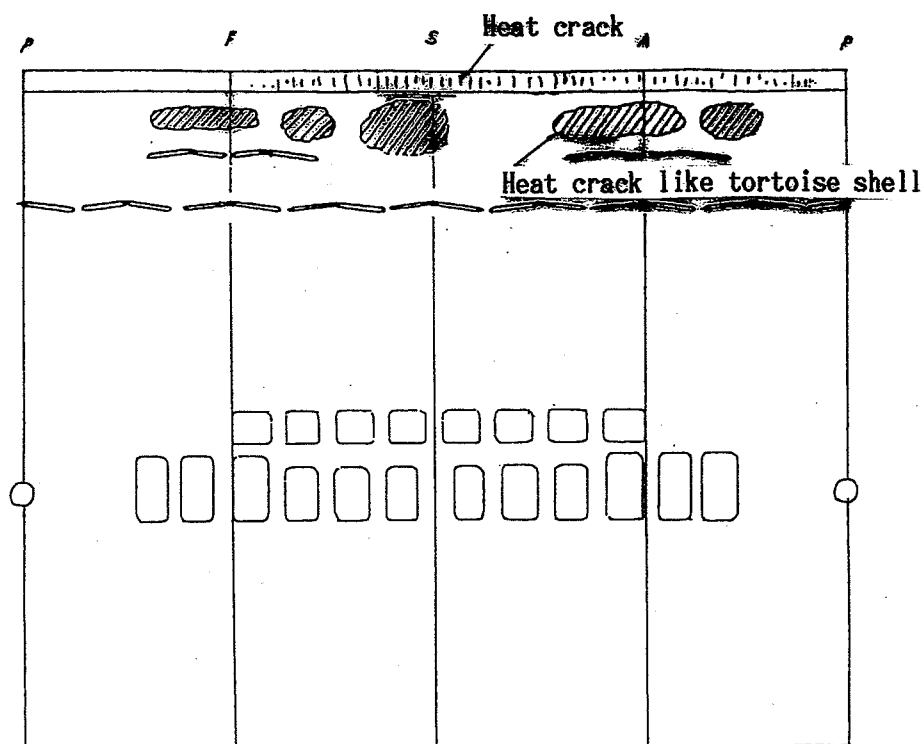
**Example-1**

**Fig.-1 Appearance of Crack on Cylinder Liner Running Surface**

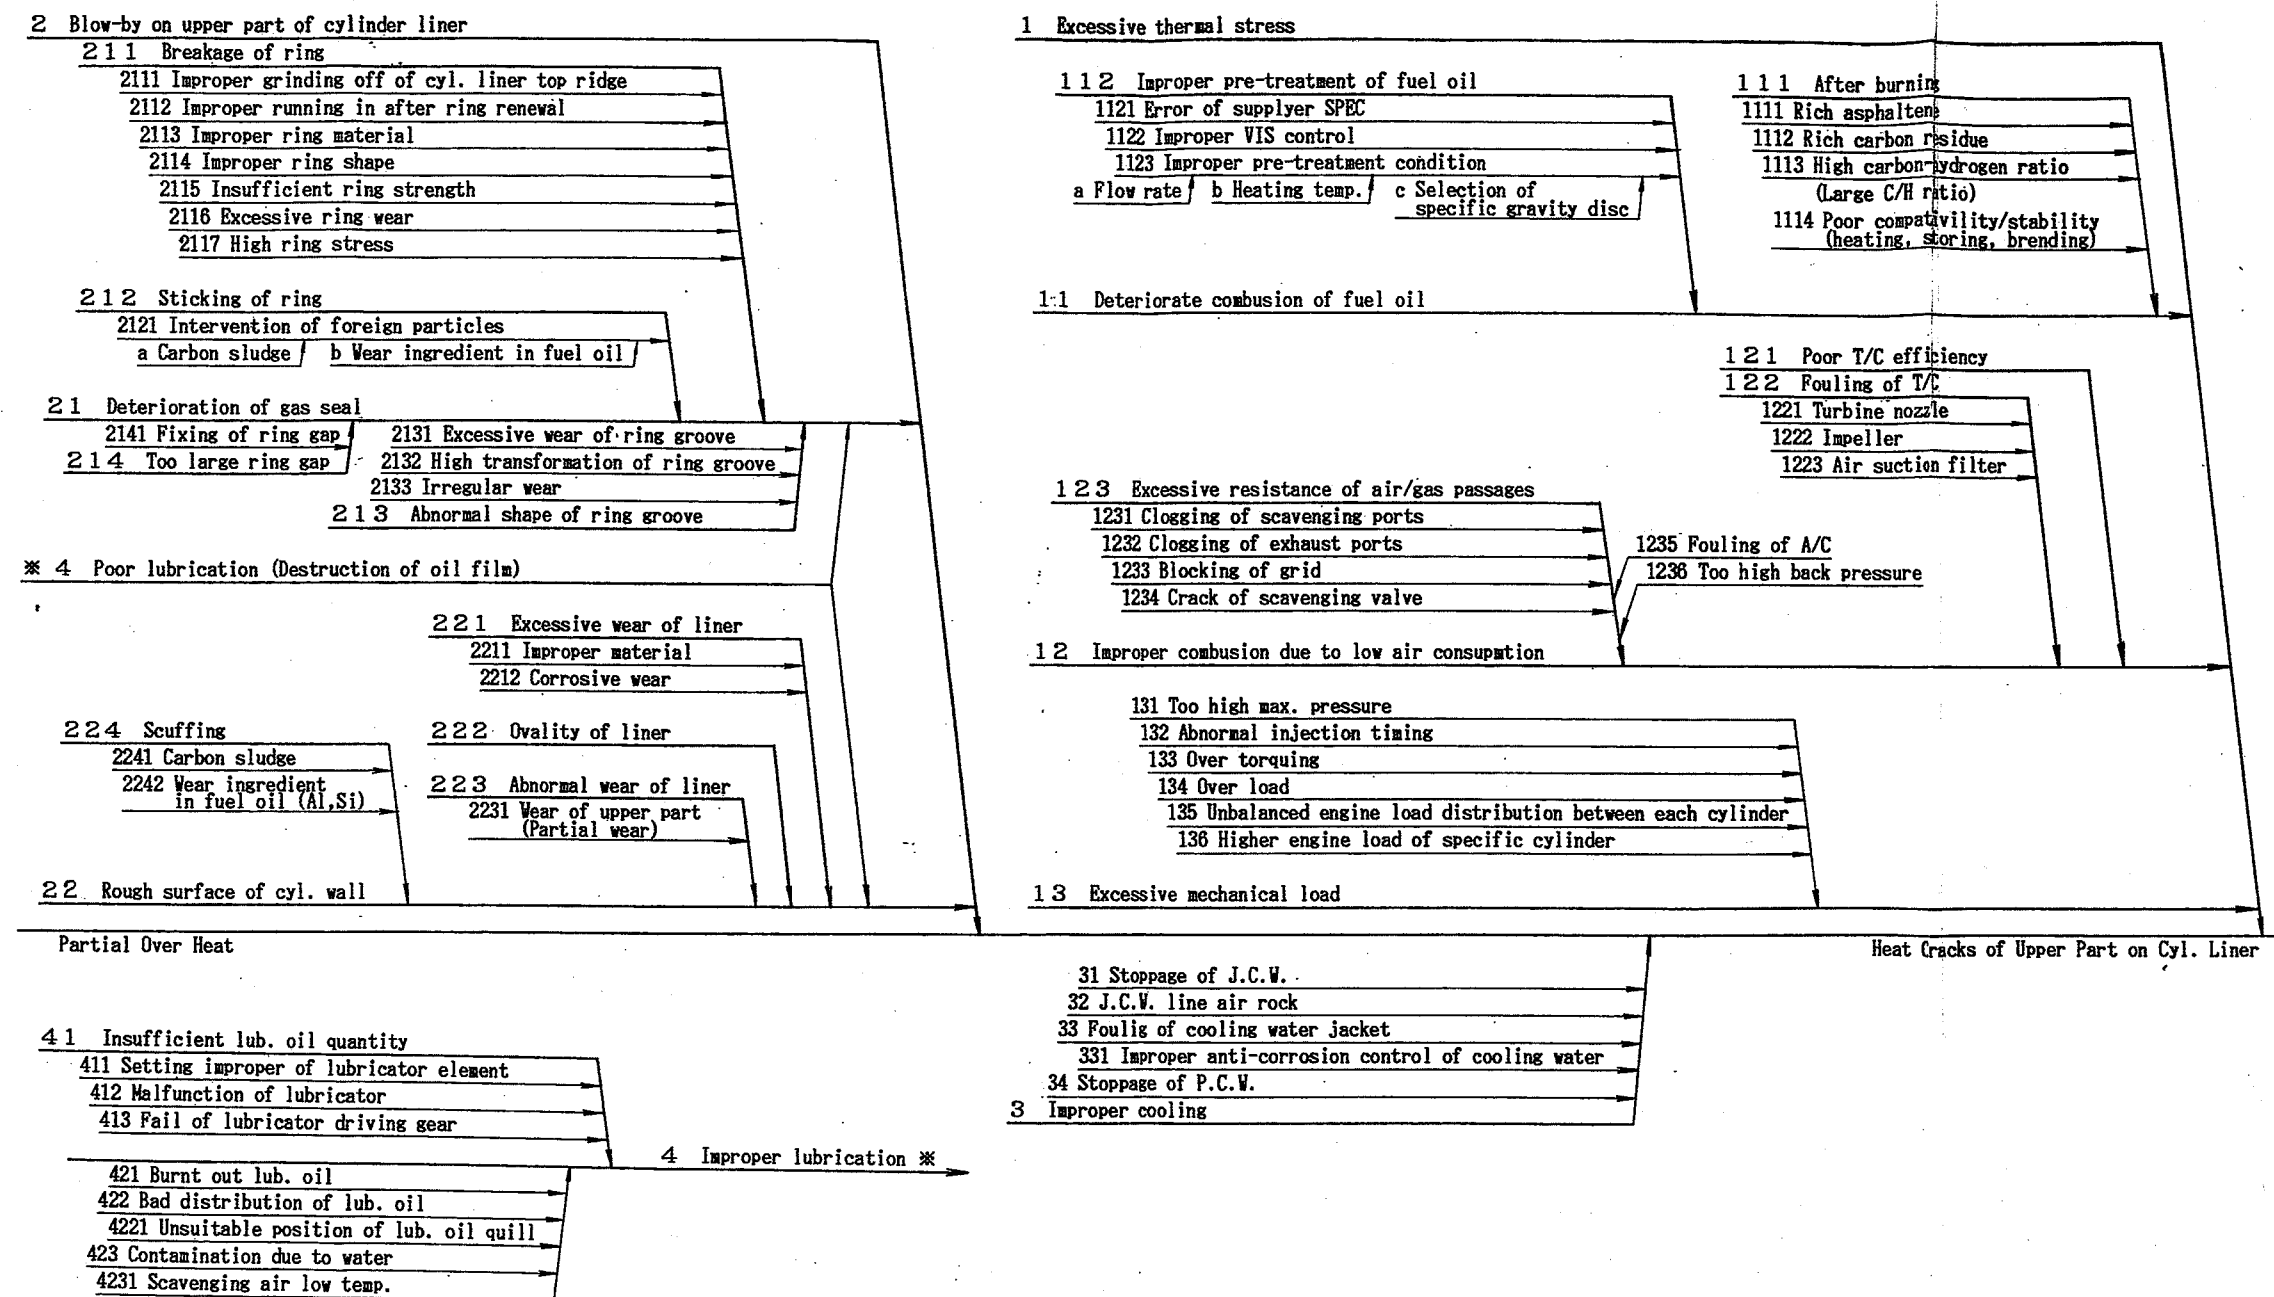
Fig.2 CYLINDER LINER HEAT CRACK  
(Heat Cracks of Upper Part on Cyl. Liner)

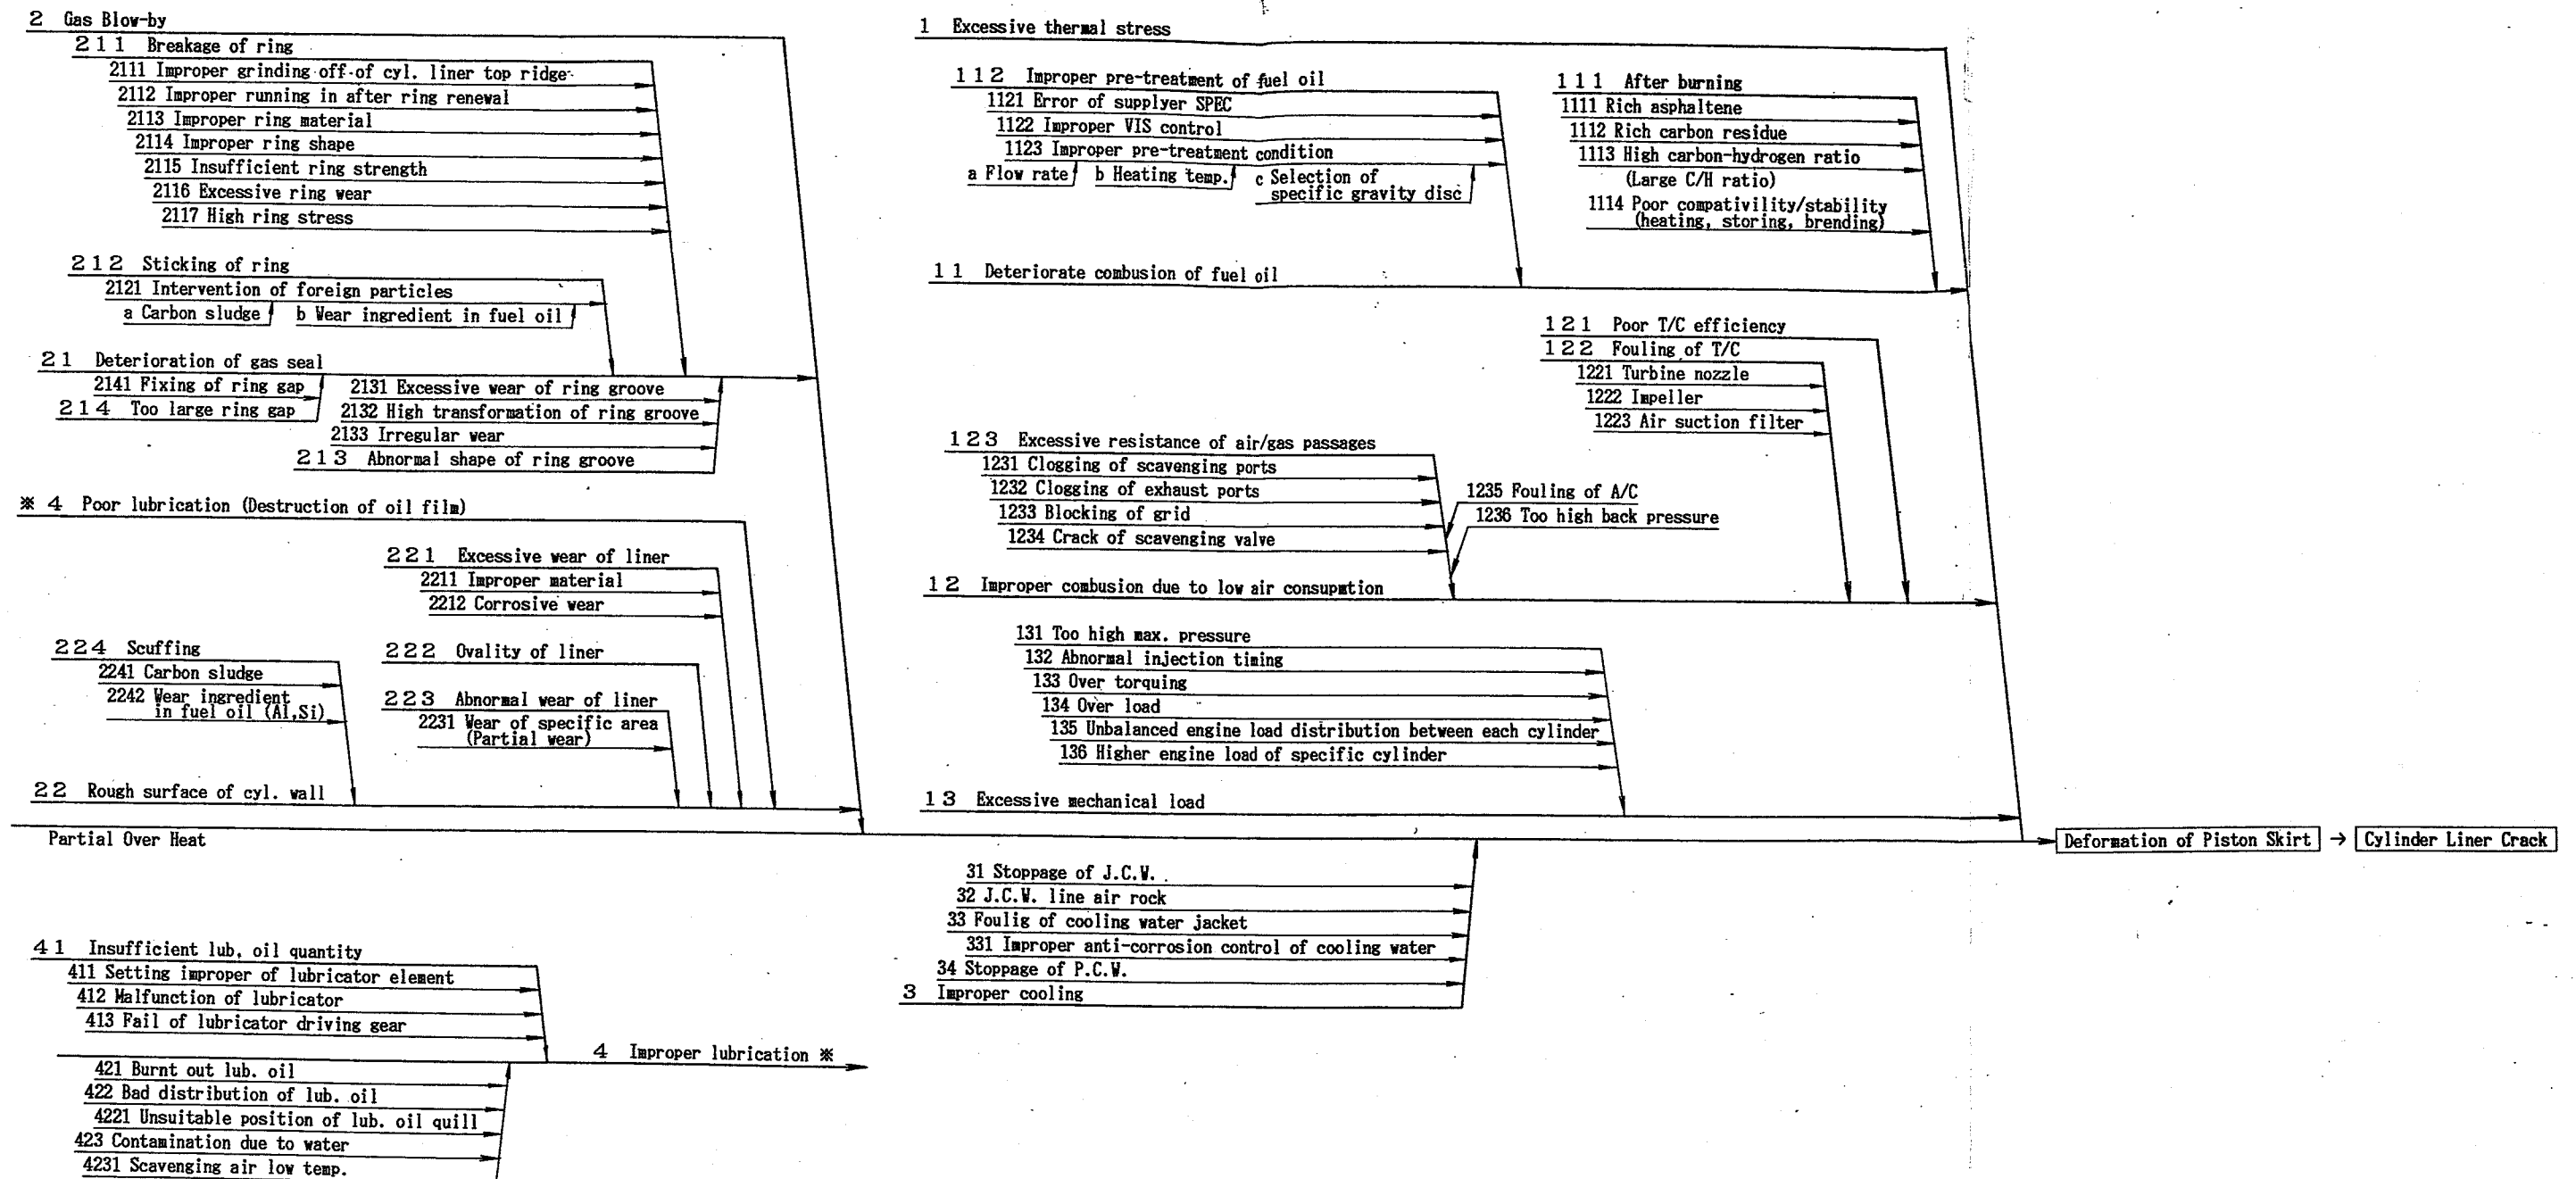
Fig.3 CYLINDER LINER HEAT CRACK

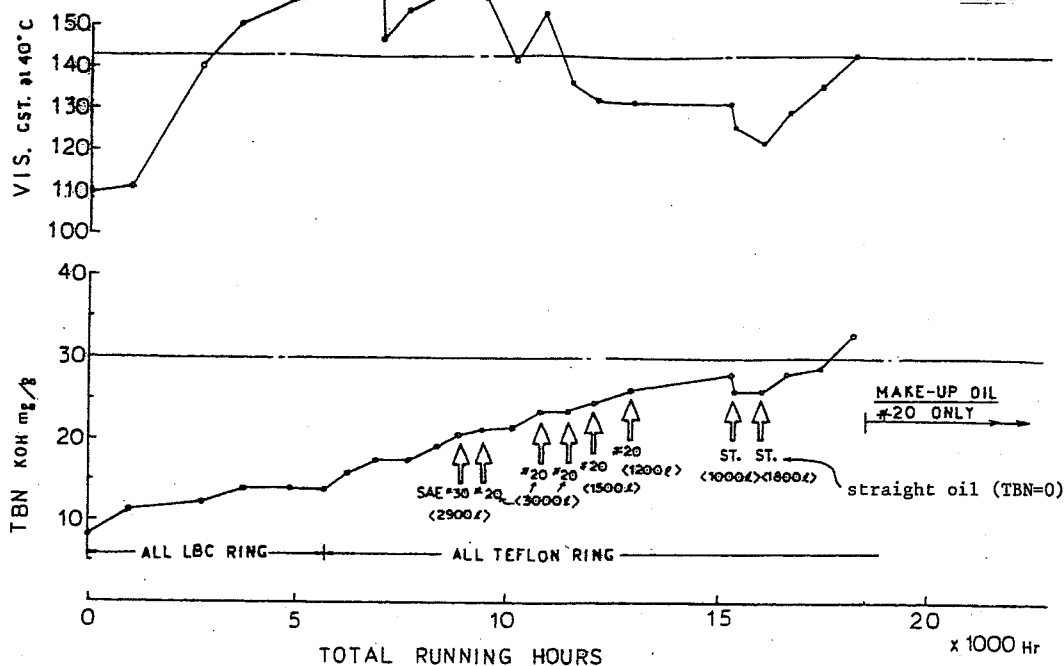
M/V "AA" 6RTA58  
ROD LEAK OIL 90L/D  
REUSE

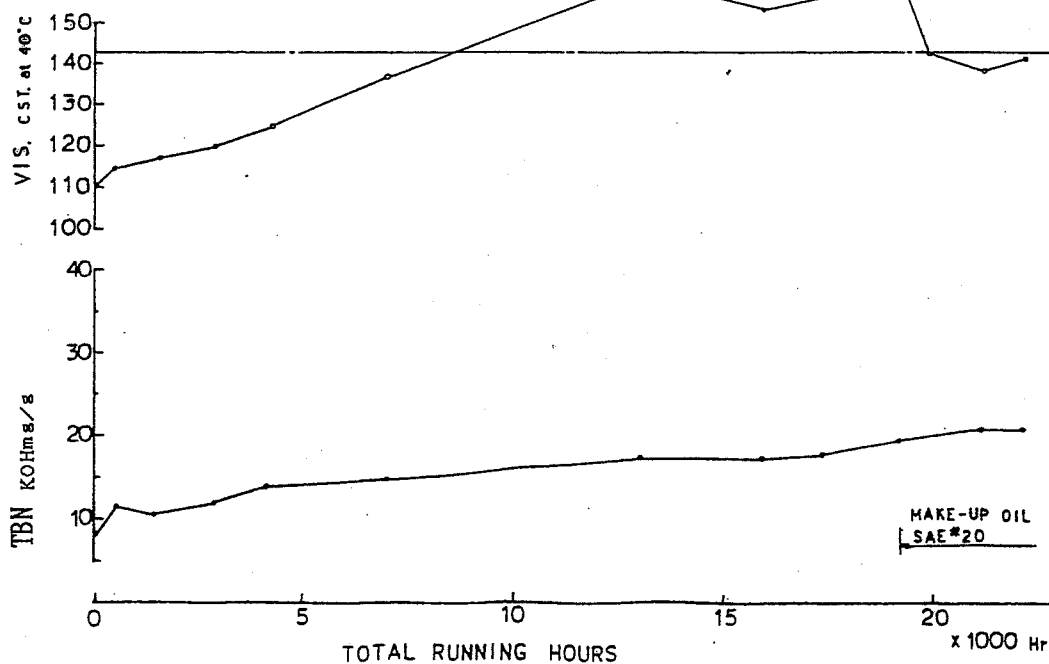
M/V "S MARU" 5RTA76  
ROD LEAK OIL 50L/D  
REUSE

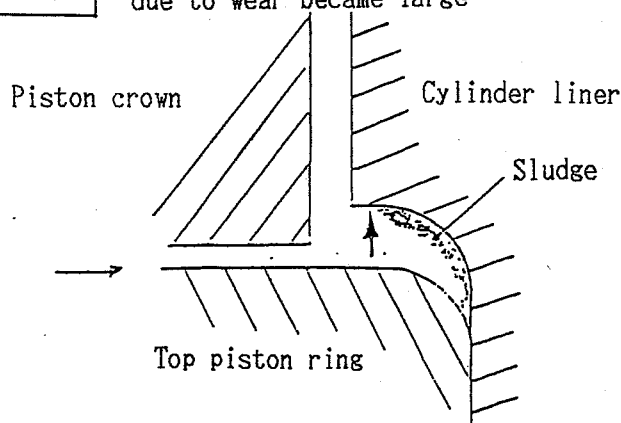
- b). It is possible that, when the aforementioned step becomes large, combustion residue scraped up by the rings accumulates on the area in the vicinity of this step and accelerates the wear of liner and rings.

Estimated state when the step (wear ridge) due to wear became large

This upper groove prevents this trouble. ( See Fig.2. )

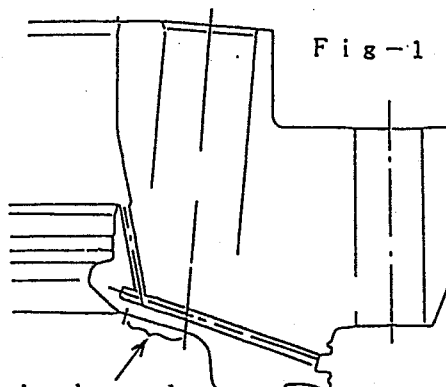
Area where crack is observed

In addition, it is also recommended that frequent inspections of the cylinder covers shall be carried out in order to verify their soundness. Such inspections can be carried out on board, by opening the cover and checking the respective coolant bores using a Borescope or ECT (Eddy Current Testing) flaw detection technique. It is suggested that during the inspection, the scales inside the coolant bores shall be also cleaned using a paper grinder. In case any damage is discovered during the inspections, this office may be approached for conducting the necessary repairs.
