# Corrosion Protection

*This chapter describes the bonding system that protects components against corrosion.*

Viking 61FY has a bonding system to protect the vessel as much as possible from severe electrolytic corrosion of propellers, shafts, rudders, fuel tanks, etc. caused by electrical currents and warm seawater. Essential to the cathodic protection system is an 8 gauge green and yellow common bonding wire connecting protected components to two sacrificial zinc anodes, port and starboard under the hull.

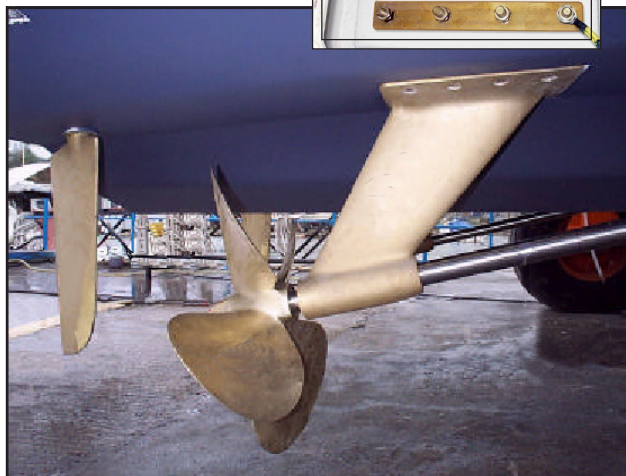
### P brackets, **B**

Struts connect to bonding through these brackets

Props are also by Teignbridge. They employ nickel-aluminium and bronze AB2, for high running speed and corrosion resistance. Props are 5-blade 30x42; shaft threads are 42x3. Struts attach to the hull with large bolts, with the nuts torqued down onto copper alloy backing plates **B** (also called "P brackets"). Attached to these are green bonding wires connected to the studs holding the zinc anodes on the outside of the hull. This affords corrosion protection to the running gear.

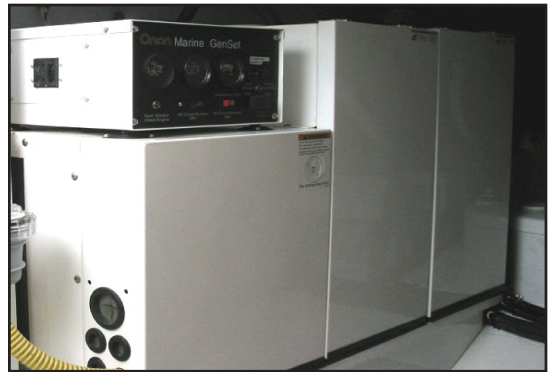
## Isolation transformers

*Isolation transformers effectively give the vessel a 'closed circuit' electrical system that is safe, and will not leak current and cause corrosion.*

In the lazarette the two 15 kVA isolation transformers have a rated input of 100 amps @ 240 volts. Shore power coming aboard is isolated through the transformer windings from any direct contact with outside grounds. ONLY red, black and green are brought into the transformer. In effect, 240 volts AC **ONLY** goes into the primary winding of each transformer. 120 volt power is produced by the transformer. This isolation protects against stray currents and electrolytic corrosion that destroys underwater fittings.

In effect, the vessel has its own CLOSED CIRCUIT electrical system which also protects crew and passengers from potentially lethal electricity flowing through them to a shore ground.
