## **REPORT OF MARINE SURVEY**

**Pre-Purchase Condition & Value.**

**"Ricochet"**

**2006 Grady White 330 Express**

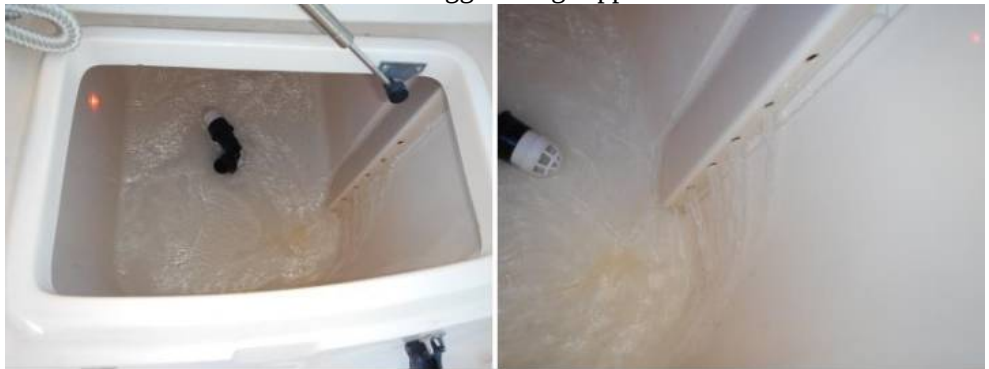
## Live bait wells:

Live well pump powered up and functioned. Capacity unknown.

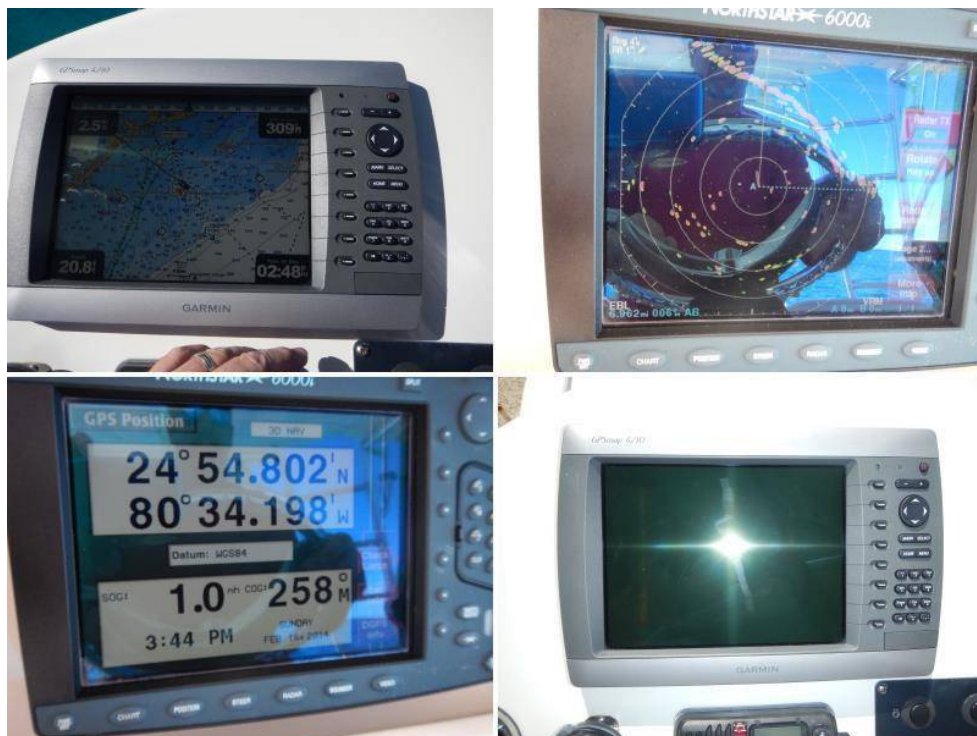
## Chart Plotter(s):

Northstar 6000 on the main helm and Garmin GPS Map 4210 on the flybridge. Units powered up and operated during the sea trial.

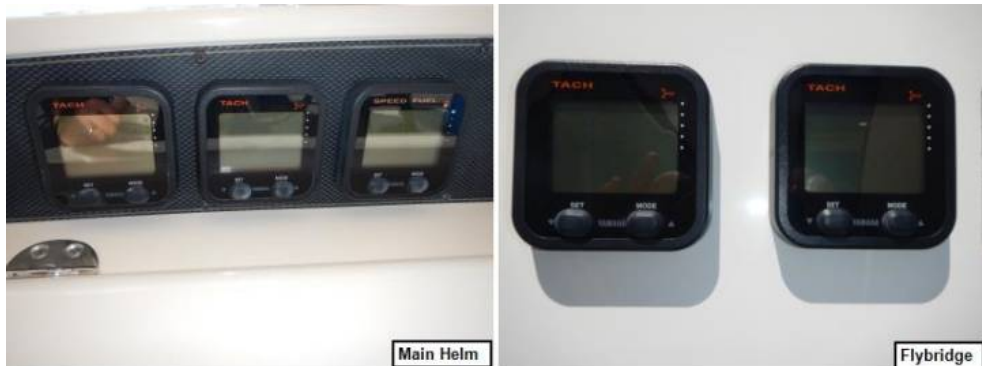
### Engine Status:

All engine instruments are Yamaha digital multi functional gauges. Gauges functioned properly with all engine status information being displayed. (Photo's were not taken of the gauges powered up as they do not photograph well in the sunlight.)

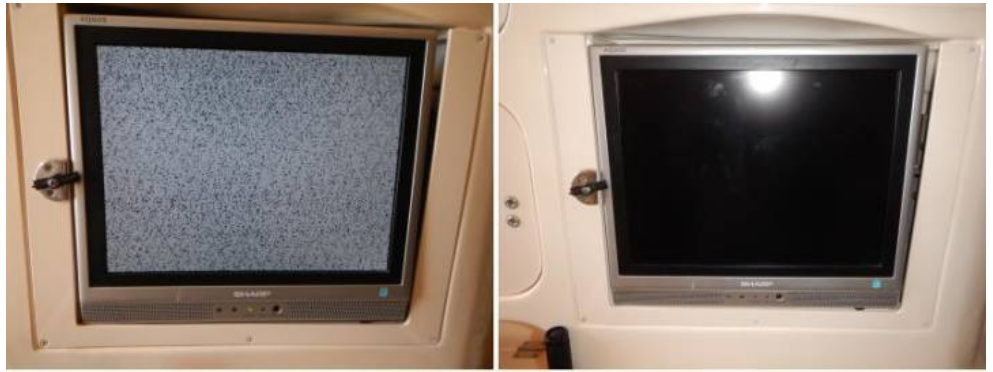
**Television:**

Cuddy cabin: Sharp Aquos, Unit is built in and well secured. Powers up.

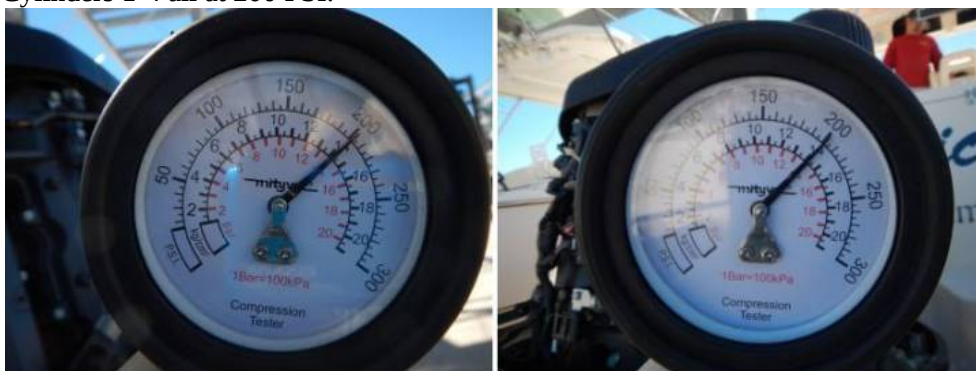
**Port Engine Cyl 5-6:**

Cylinders 5-6 at 200 PSI.

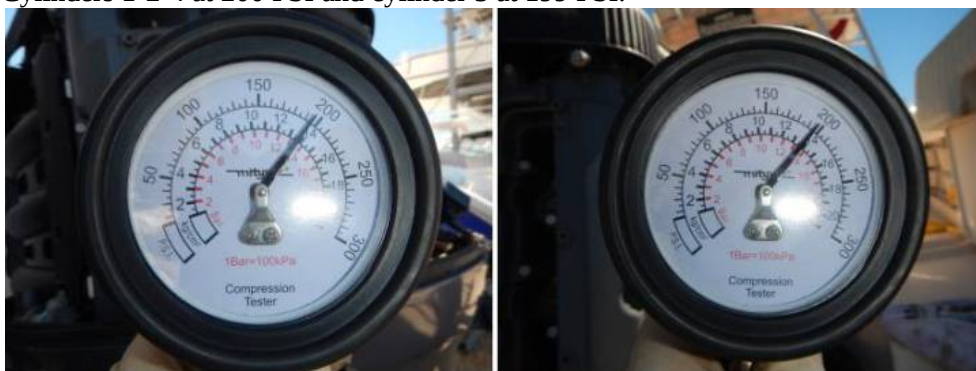
**STBD Cyl 5-6:**

Cylinders at 200 PSI.
