| SHIP NAME | APL POLAND |
| DWG. NO. | MA8-LA2007F |

## MITSUBISHI SERVICE INFORMATION INDEX FOR MITSUBISHI-SULZER RT-flex96C DIESEL ENGINE

# S.No.2228

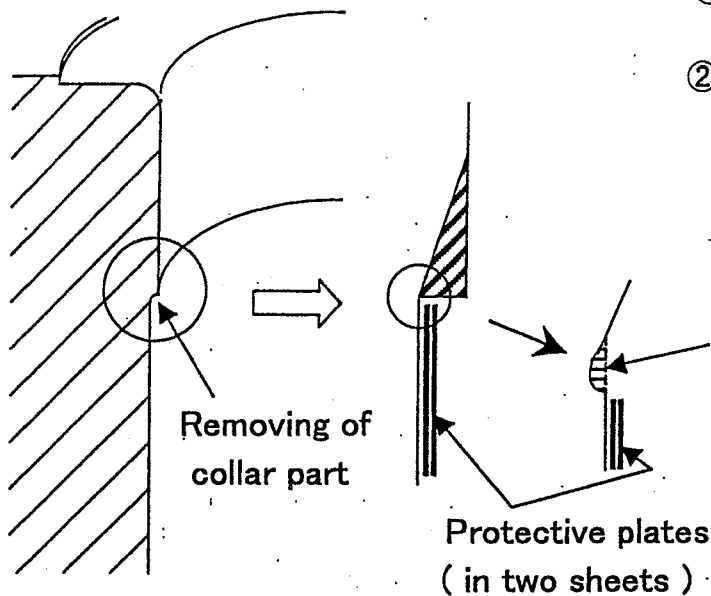
( Shape of top ridge )

2) There is a possibility of getting burned while the cylinder liner temperature is high.

Carry out the work after the temperature becomes lower or sufficient heat insulated measures are taken.

- ① To be roughly ground by using a sander grinder.
  - ② To be finished by using a fine sander or stone grinder with bar.
- Finishing to be carried out so as not to leave collar and make the shape as shown in the following figure.

Recess to be made a little

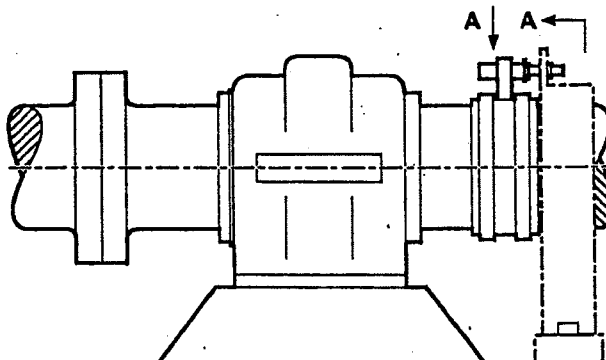
Typical earthing arrangement for the main shaft

If these devices do not work effectively, it is assumed that damage due to spark erosion occurs on bearing metals and may lead to serious troubles. Therefore, we would like to ask you to carry out the periodical maintenance for these devices.

Normally, it is necessary to inspect wear and damage on brushes (4 ) and monitoring brush (11) shown in the following figure.

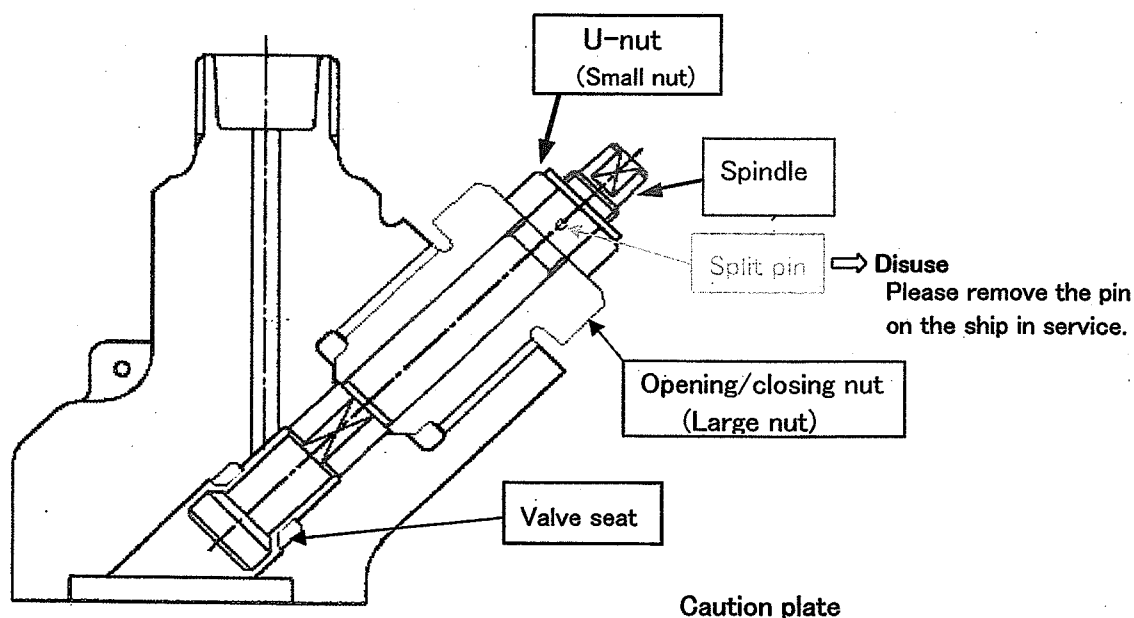
Fig. 1 AB-1 Type Indicator Valve

The back-seat type indicator valve (AB-1type) is structured as shown in Fig. 1 and the spindle is tightened & fixed to the opening/closing nut with U-nut and unifies with them, and the pressure in the cylinder is led into the indicator.

The opening and closing of the indicator valve is done by operating the opening/closing nut (clockwise⇒opening). However, when the indicator valve is opened/closed, the U-nut is turned counterclockwise by mistake (properly the opening/closing nut has to be turned), by which the U-nut is loosened and the clearance occurs between the opening/closing nut and the U-nut and then gas blow-by occurs through the seat part of the spindle.

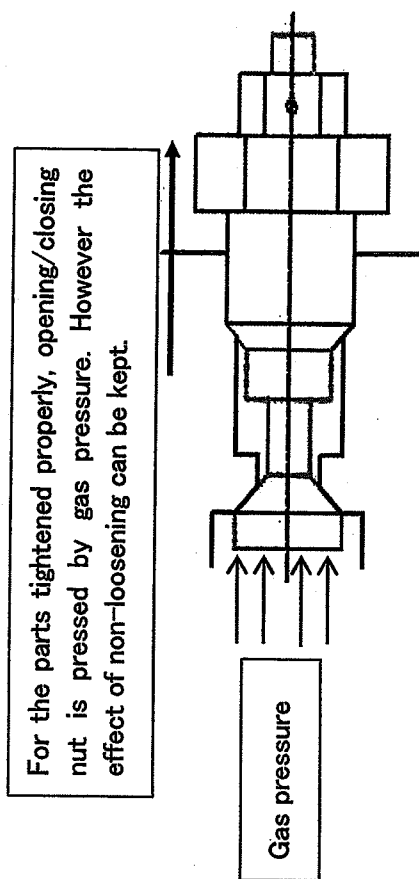
Fig. 2 Mechanism of Gas Blow-by due to Loosening of U-nut

In the case that U-nut is sufficiently tightened:

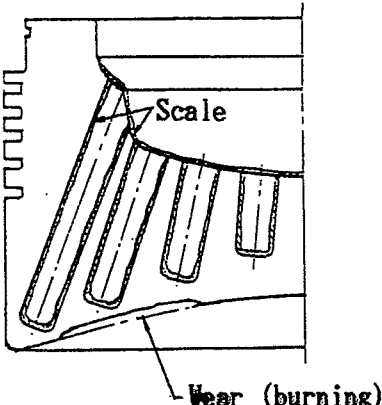
| <p>Special attention should be paid for wear (burning) on combustion surface of piston head as we informed you through the Service Information MSI-8810 previously published.</p> <p>In the Service Information, a reduction in cooling effect is mentioned as one cause of wear.</p> <p>As the result of recent investigation of piston head which is subject to severe burning, it proved that a large amount of scale (oily sludge) had adhered to the cooling side including cooling bores, and we confirmed that this had become a cause of burning.</p> <p>Hereafter, from the viewpoint of preventing this problem, we would recommend you to overhaul piston heads and inspect inside of at least one to two heads in the first two to three years after ship commissioning even if there is no abnormality on combustion surface irrespective of water cooled, or oil cooled, and then, to carry out piston overhauling for cleaning of scale on inner cooling surface at intervals of three to four years depending on its conditions.</p> <p>Further, in case that occurrences of abnormal burning are found, it is necessary for you to carry out piston overhauling immediately and check the state of cooling side.</p> | | | |

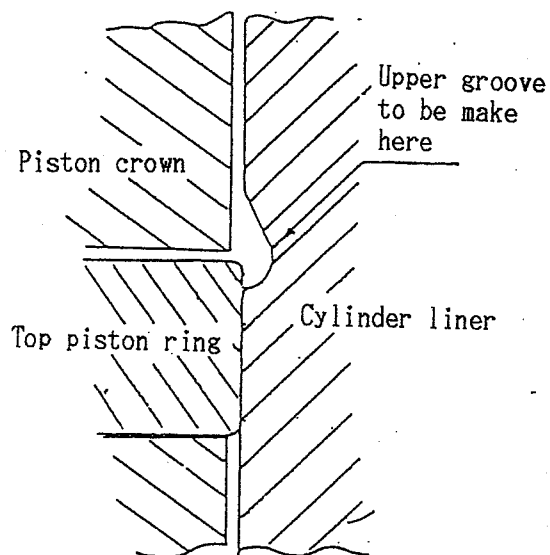
Fig. 2

When the step is left on the liner, the ring groove is loaded with excessive force and wears down rapidly.

- b). It is possible that, when the aforementioned step becomes large, combustion residue scraped up by the rings accumulates on the area in the vicinity of this step and accelerates the wear of liner and rings.

This upper groove prevents this trouble. ( See Fig.2. )

Estimated state when the step (wear ridge) due to wear became large

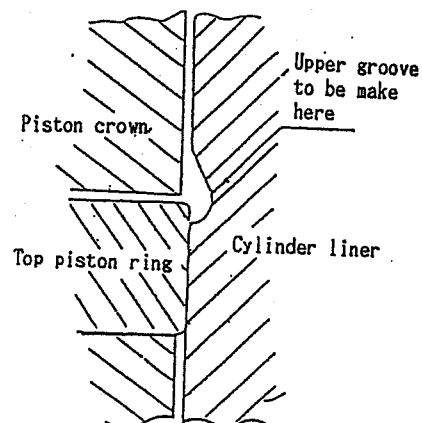
Such cases can often be seen recently that the wear of ring grooves progresses in a short time after pistons have been repaired (mark  $\Rightarrow$  in the above figure) this wear is considered to be attributable to the insufficient removal of a wear ridge or to the fact that it has been left as it is due to timewise limitation or oblivion.

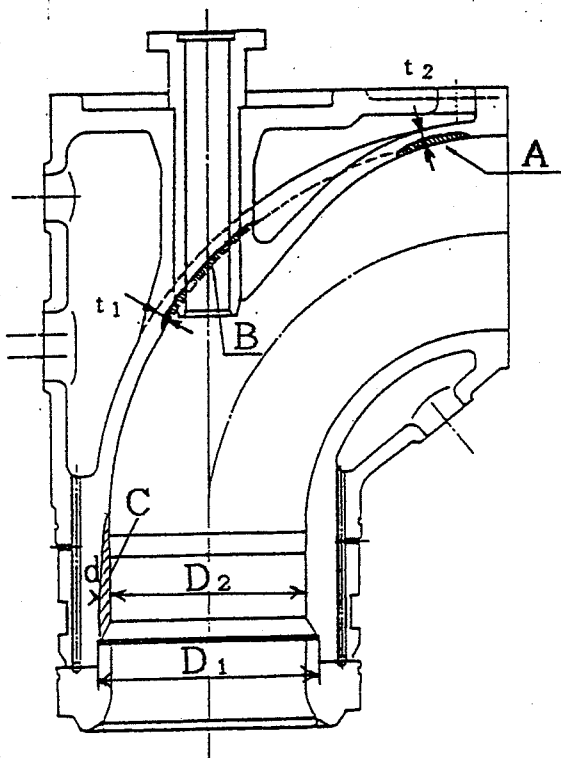
Allowable depth of corrosion is shown in the table below. But we ask you to repair cages of which values of corrosion depth are close to limits using the diameter  $D_1$  (the outer diameter of the valve seat spigot) as a yardstick after landing them in an early stage.

Since special techniques are necessary for repairing the valve cage because its material is cast iron, you are kindly requested to order repairing work from our company.

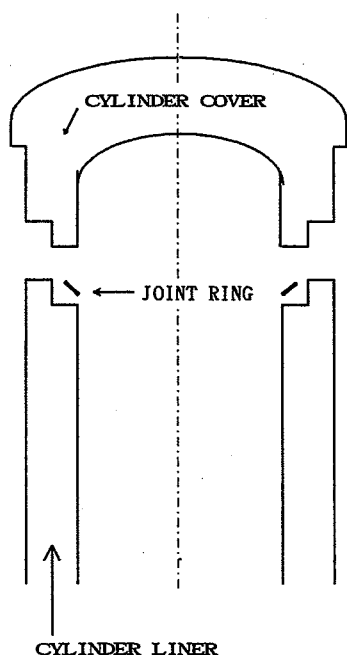
Fig 1

If the warped joint ring is installed in the wrong direction as shown in Fig.1, there is some possibility that the joint ring may be shifted and bitten by cylinder cover and cylinder liner at the time of installing cylinder cover, as shown in Fig.2.
