## **REPORT OF MARINE SURVEY**

**Pre-Purchase Condition & Value.**

**"Ricochet"**

**2006 Grady White 330 Express**

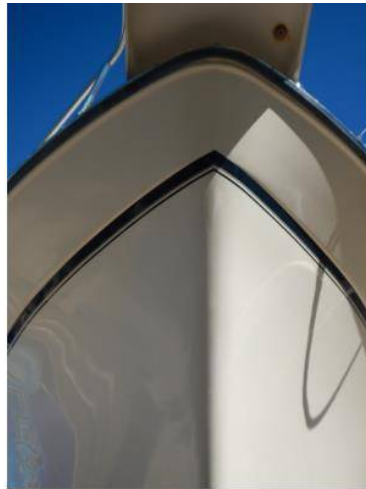
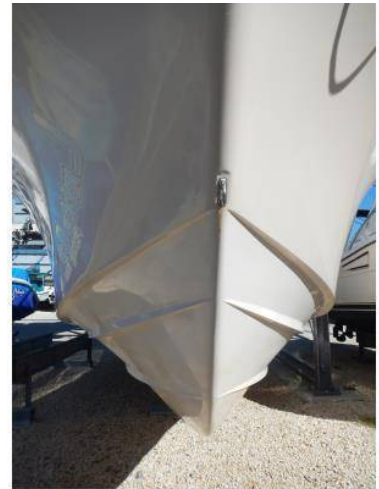
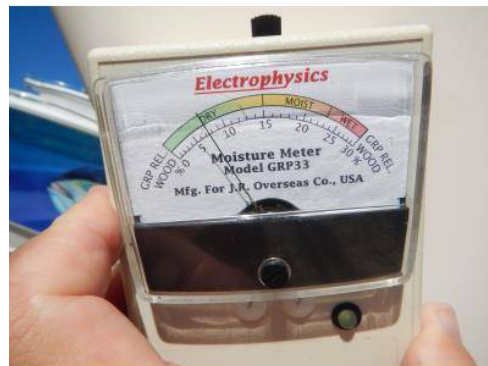
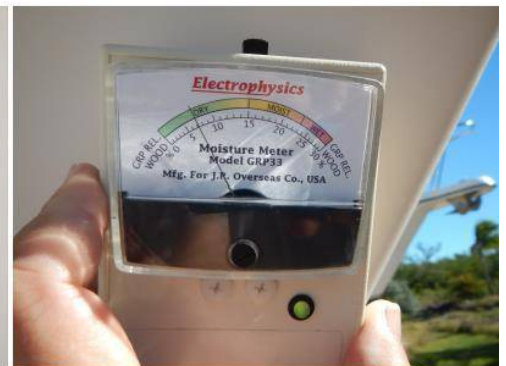
**Stem:**

Solid, no cracks on external inspection. Moisture readings relatively Dry.

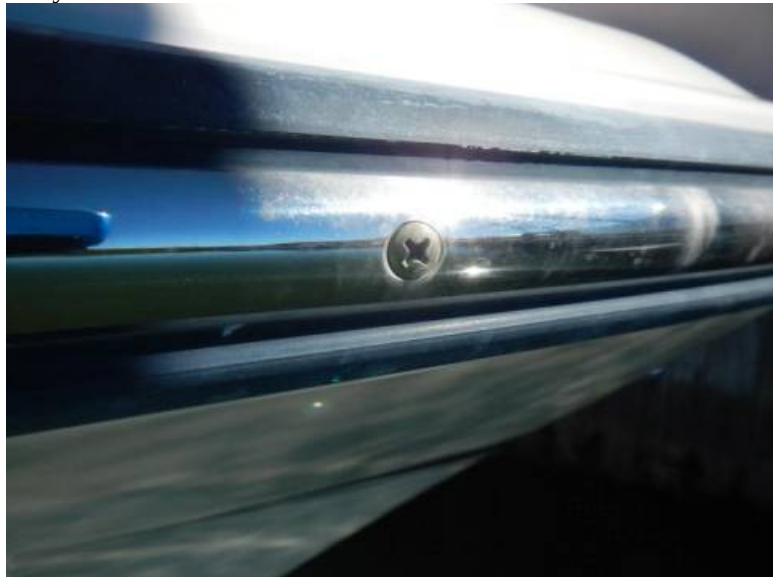
**Rub Rail:**

Rub rail is stainless steel on black plastic backing, Rub rail is in excellent condition. No gouges or dents in rail.

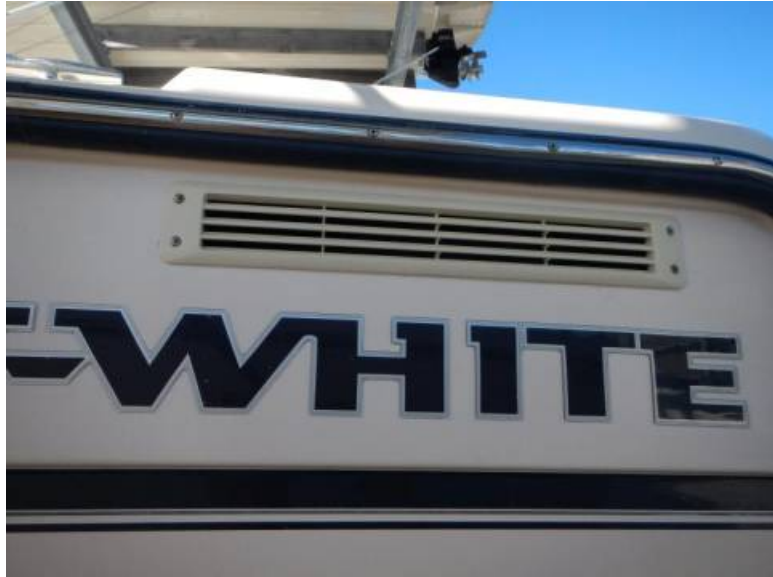
**Engine vents:**

Vents are attached and in good condition- no cracks sighted.

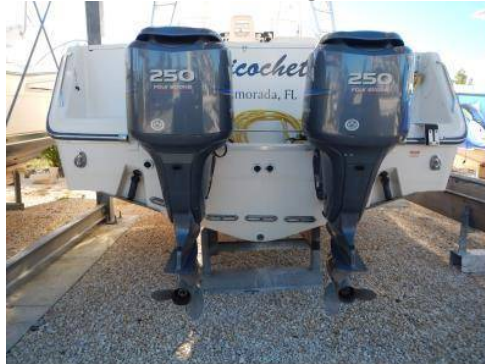
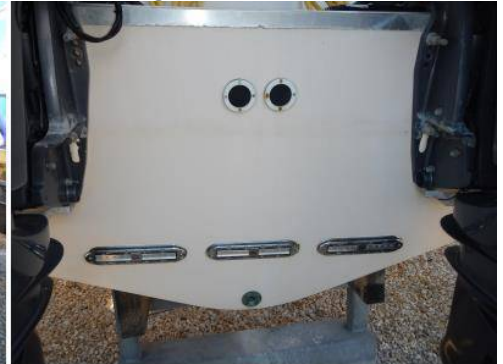
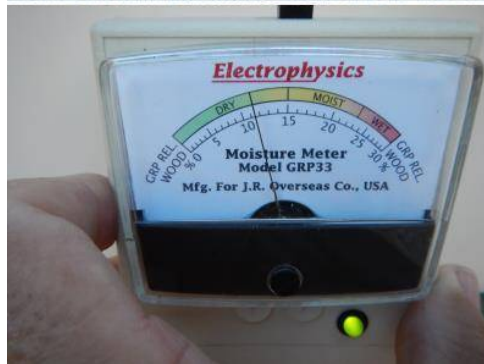
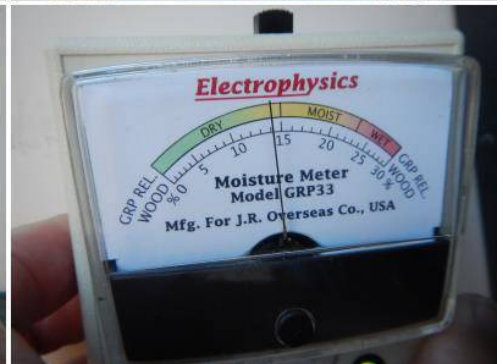
**Transom:**

Conventional transom, Well secured, no cracks or defects sighted. Moisture readings were relatively Dry. No delamination when checked with a percussion hammer.

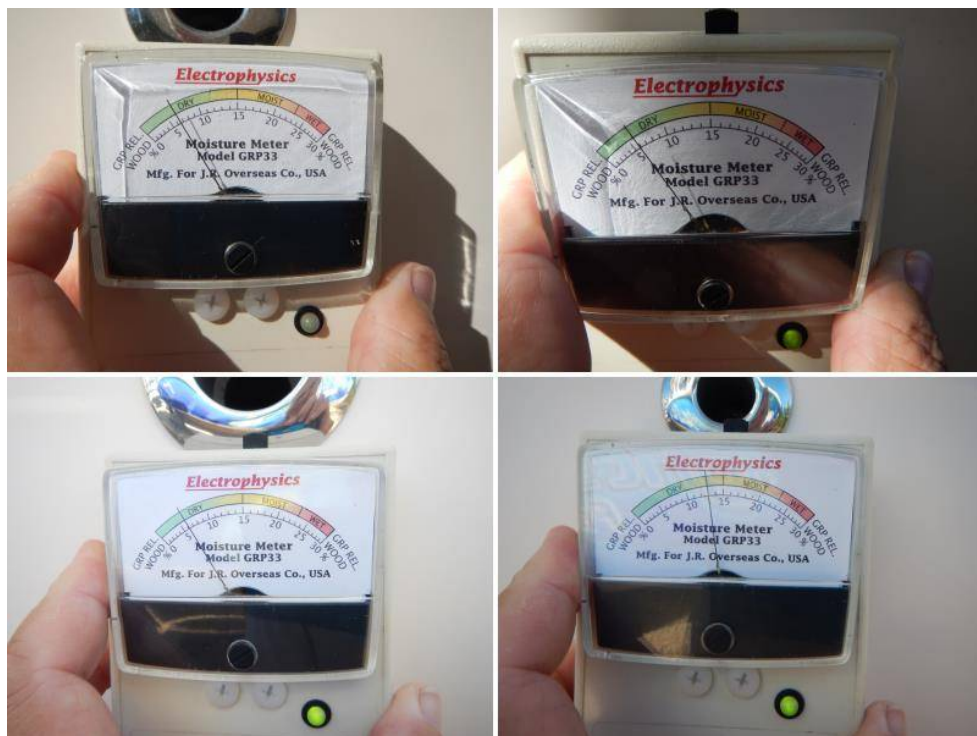
## Moisture/Delamination:

All moisture meter readings on side hull near the water line and surrounding thru hull fittings were relatively dry with normal comparative moisture meter readings.

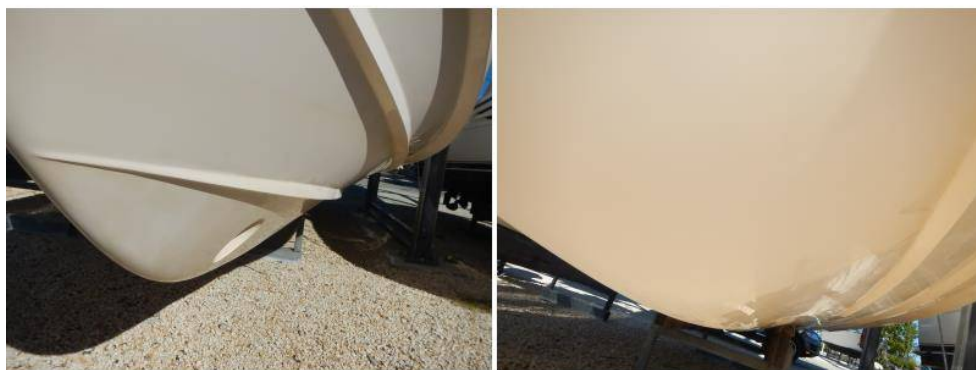
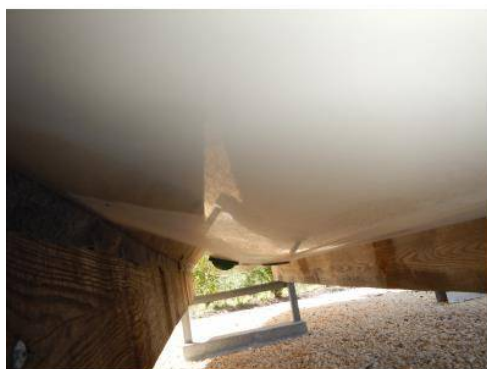
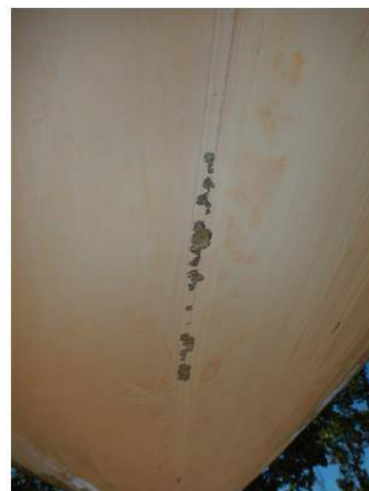
**Construction Material:**

Fiberglass, some gelcoat damage to the bottom running fore and aft.

| Findings: | Recommendations: |
|---|---|
| Slight grounding damage on the bottom. | Have a qualified fiberglass technician repair gelcoat |

damage.

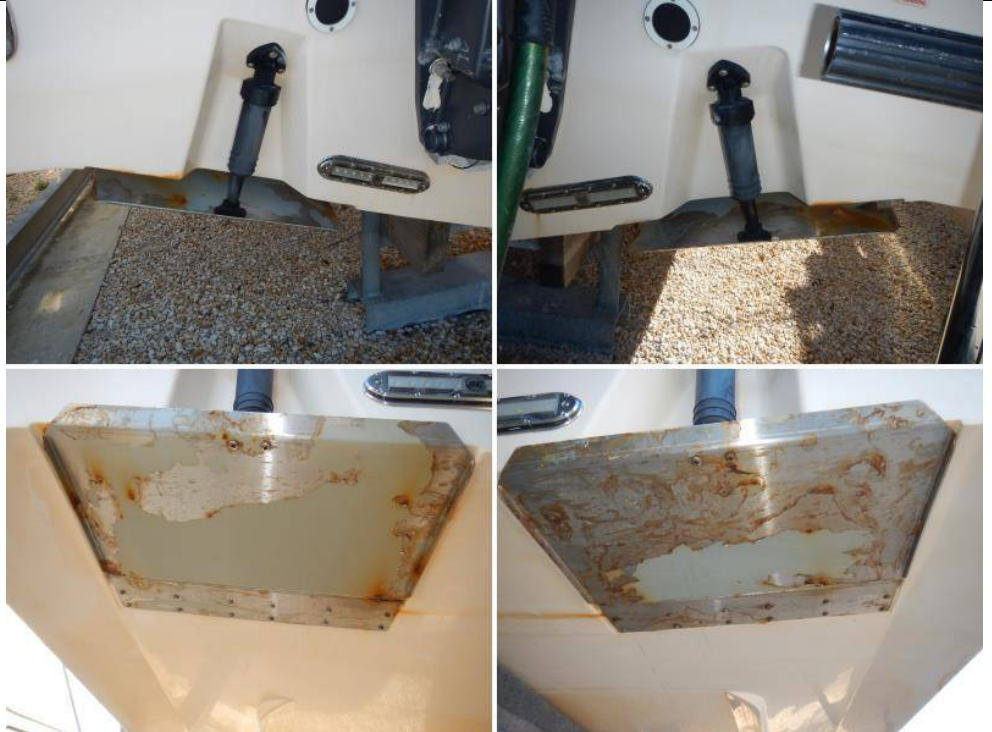
### Trim tabs:

Bennett single ram hydraulic trim tabs. Hydraulic, Power up and function OK. No leaks sighted. Power up and function OK from upper and lower helm.

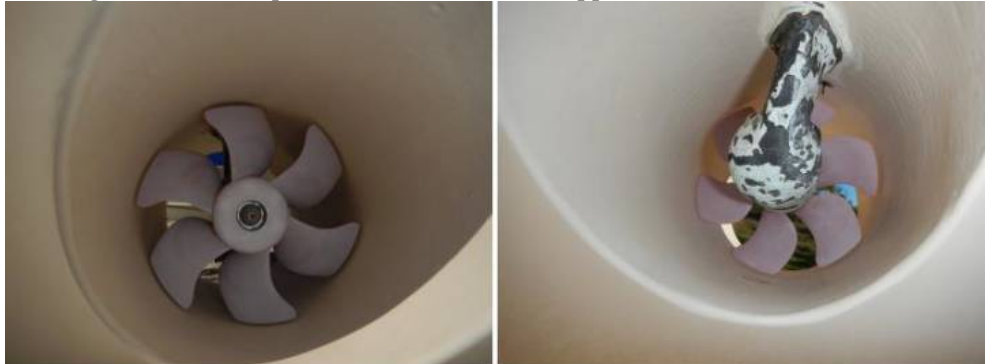
### Bow thruster(s):

Vetus bow thrusters, 6 blades all in good condition. Unit powered up and functioned properly during the sea trial.

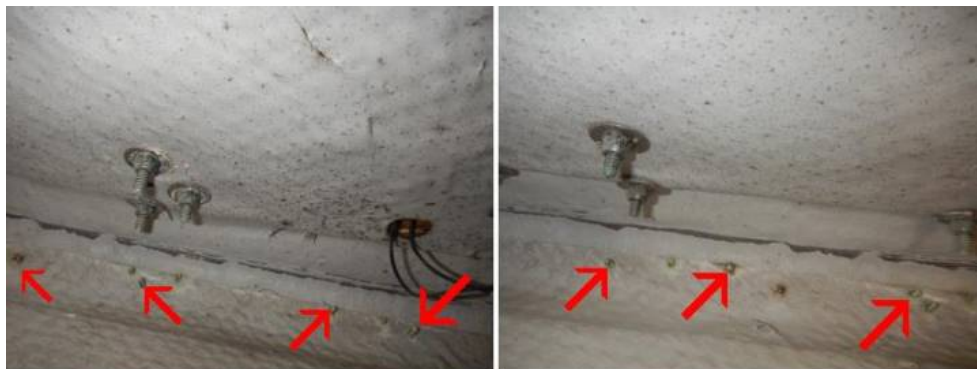
**Hull to Deck Joint:**

Overlap (Shoe box type), Fasteners sighted were stainless steel bolts spaced approximately 6" to 8". Appear secure. as sighted in anchor locker No leaks sighted thru any part of hull to deck joint area

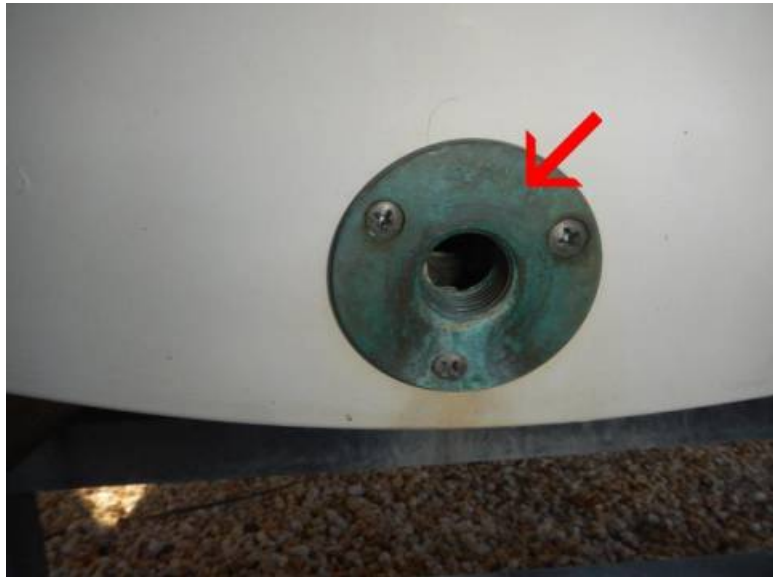
**Drain Plug:**

Drain plug is not installed. Be sure to install drain plug before launching vessel. All sea valves in like good condition and all valves are operable. *Note: Tapered wooden plugs tied to sea valves are an inexpensive safety item and highly recommended under current ABYC standards.*

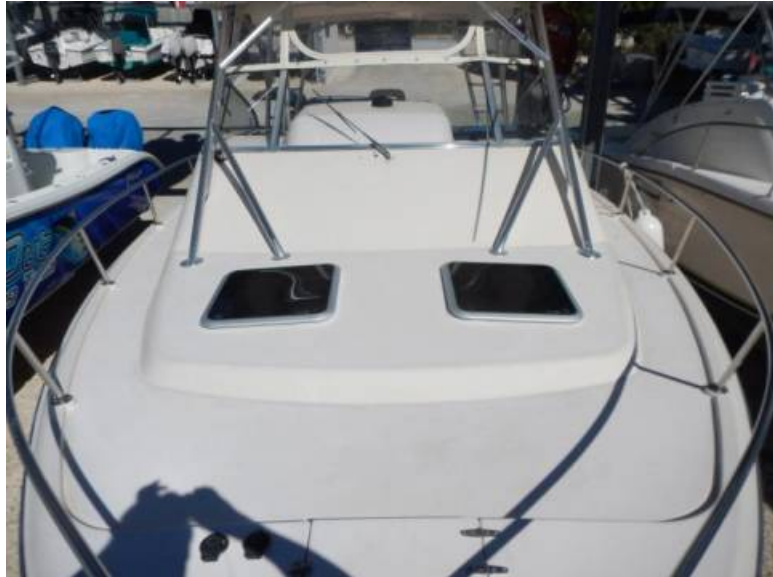
**Deck Surface:**

Molded, cored fiberglass deck construction (core not sampled). White gel coat with molded in non skid fiberglass surface. Good condition. Deck is solid under foot, no soft spots discovered and no visible cracks or chips sighted.

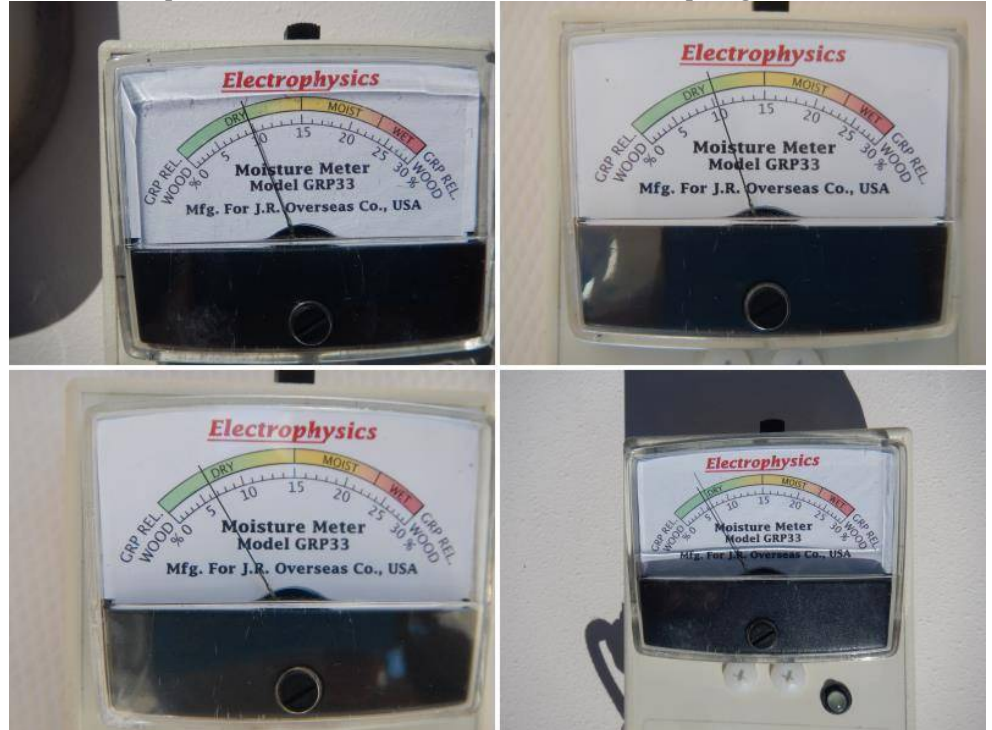
**Moisture/Delamination:**

Moisture meter readings were all relatively Dry. No delamination or soft spots discovered.

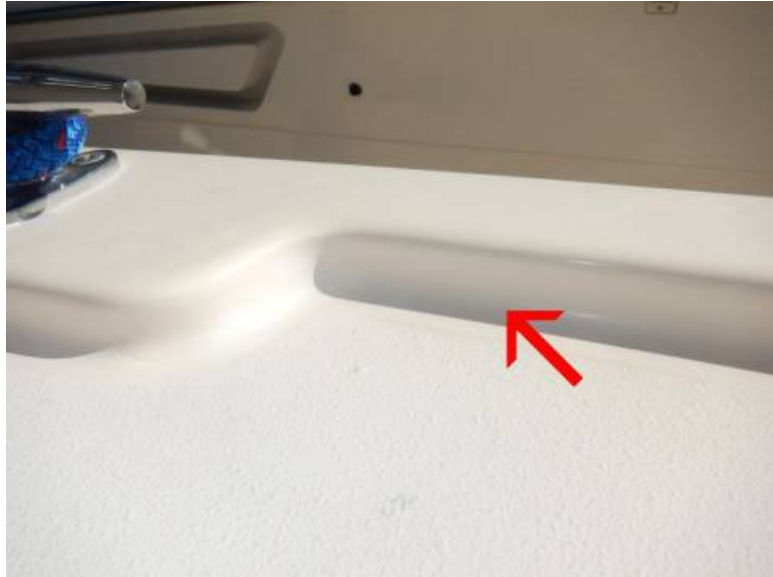
**Toe Rail(s):**

Molded in, no cracks or separation sighted.

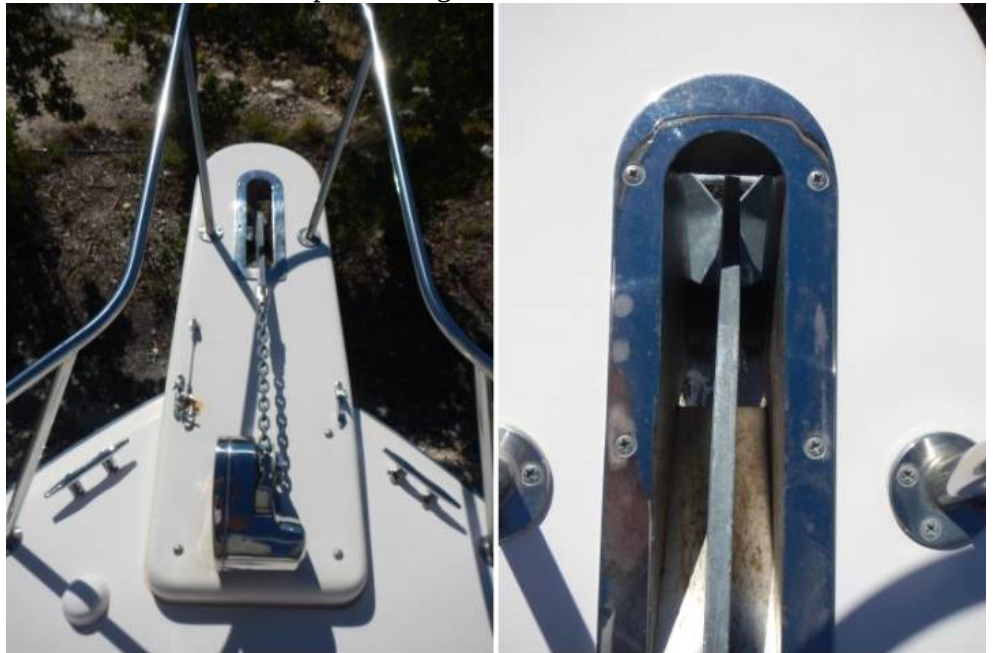
**Anchor platform:**

Integrally molded FRP platform with attached anchor roller assembly. Well secured-no cracks sighted.

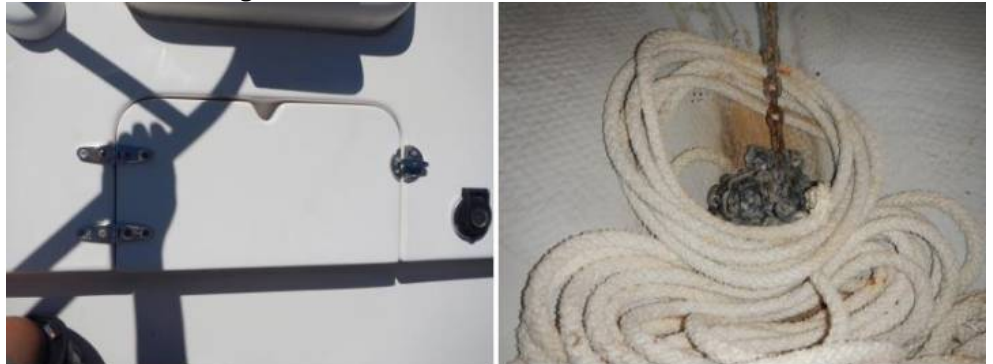
**Anchor/chain locker:**

Yes accessed from top deck with hatch lock. Functional.

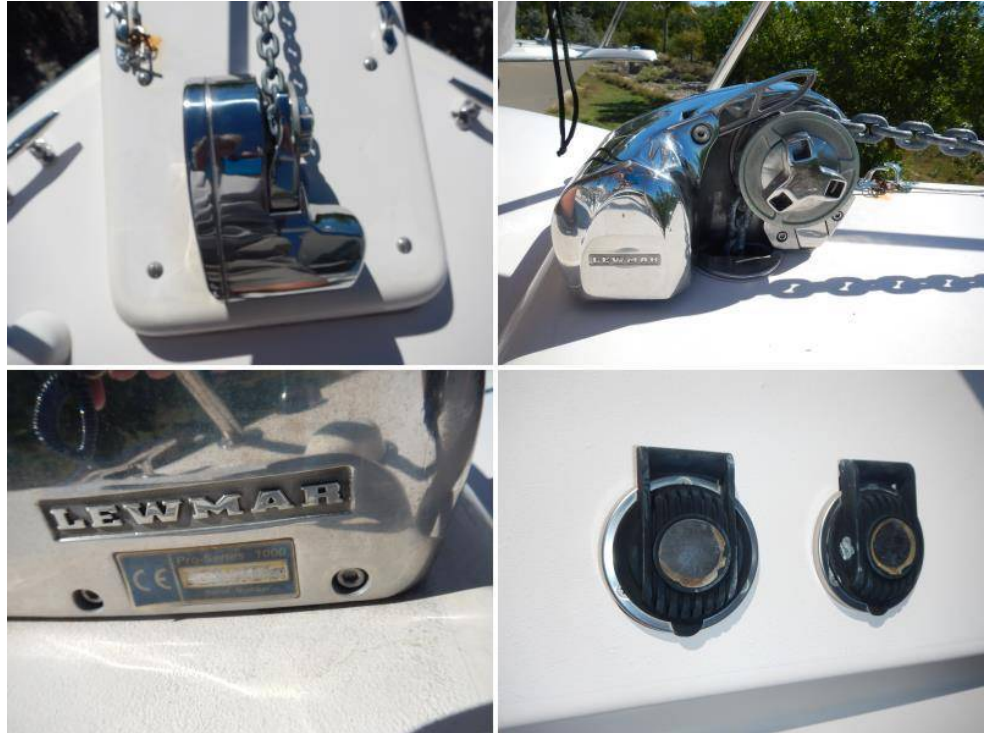
**Windlass:**

Lewmar, Pro Series 1000 Helm and foot controls for raising or lowering anchor are both fully functional.

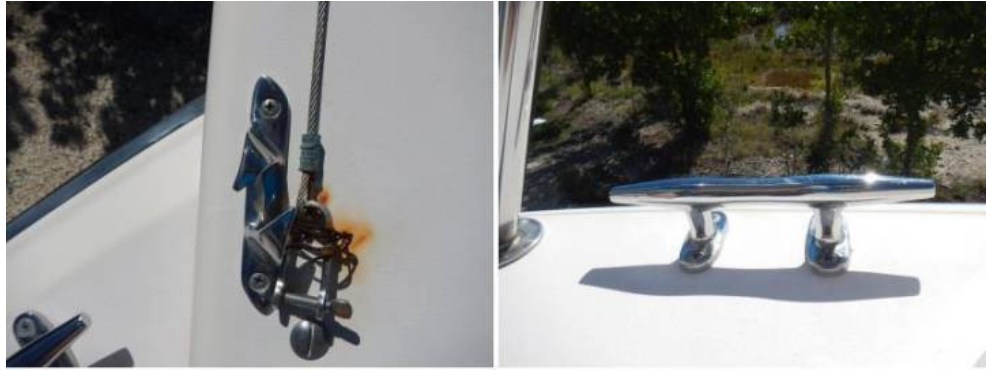
**Cleats & Fairleads:**

Horn cleats are all well secured to deck and functional.

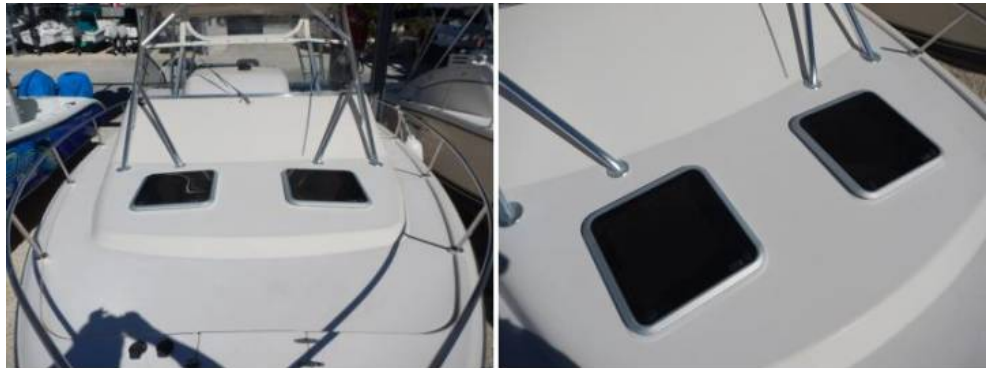
**Deck Hatches:**

Yes, well secured, seals in good condition, support arm(s) in place.

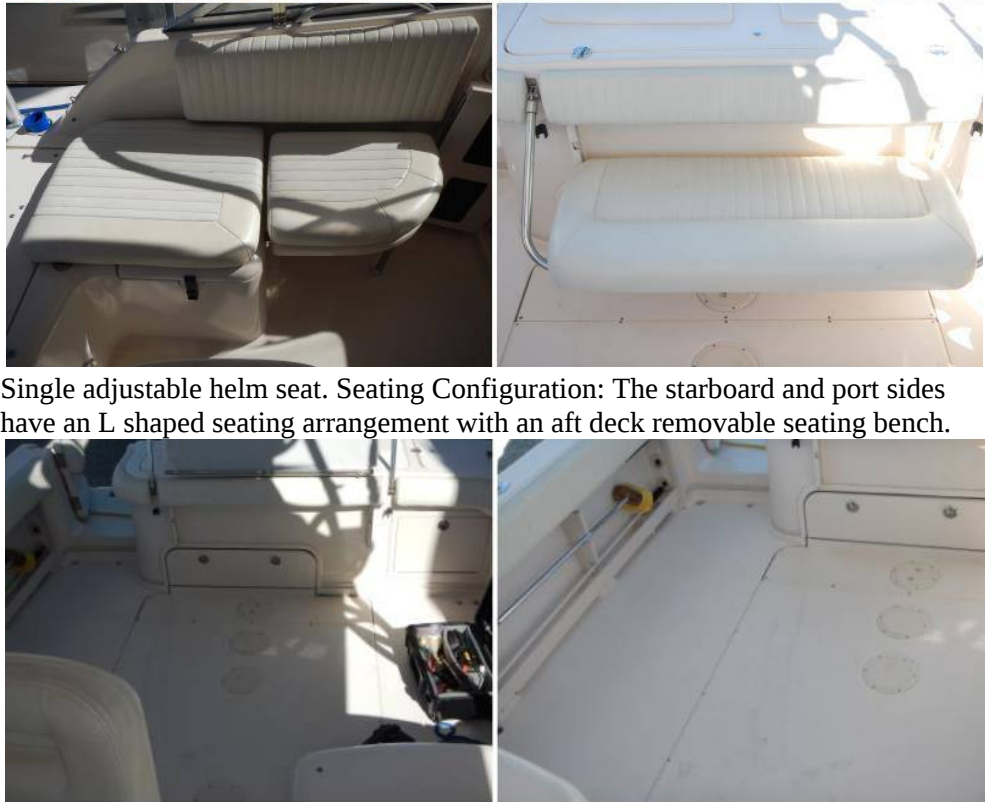
## Sole:

FRP (fiber reinforced plastic) with molded in non skid.

All moisture meter readings on sole were relatively dry with normal comparative moisture meter readings.

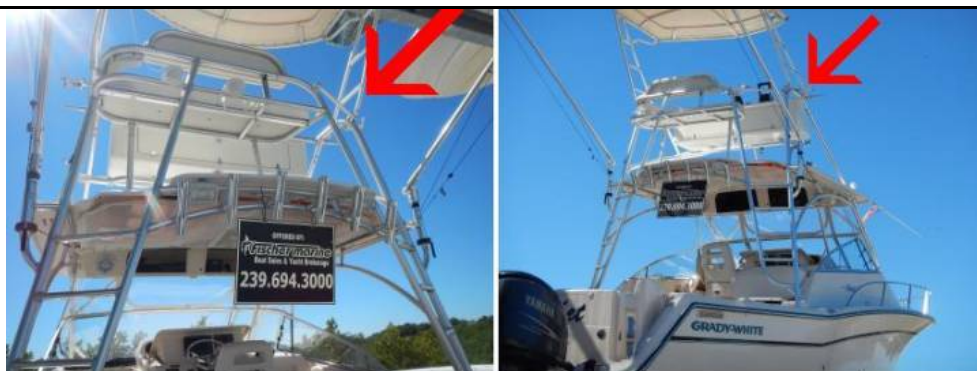
**Construction material:**

Stainless steel frame with FRP sole and top. Well secured with screws at base.

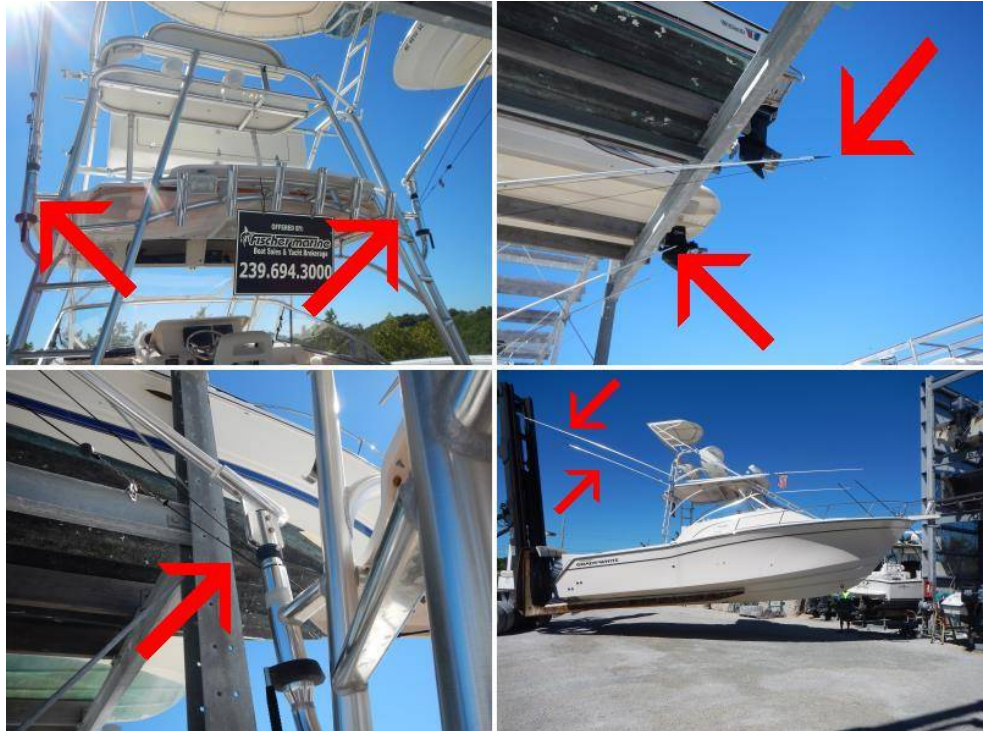
## Outriggers:

Lee Pro Series 24' stainless steel outriggers. Rigs appear to be functional.

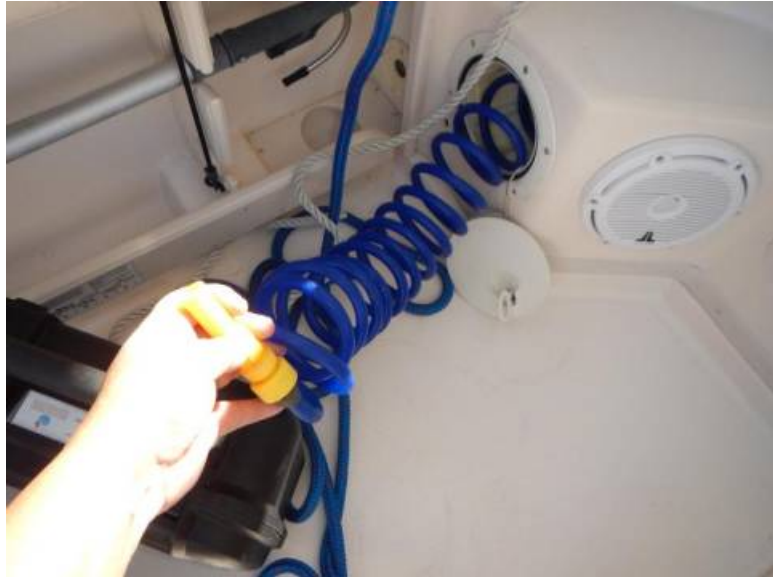
**Wash Down System:**

Raw water and fresh water wash down. No water in the tank but unit powered up using raw water.

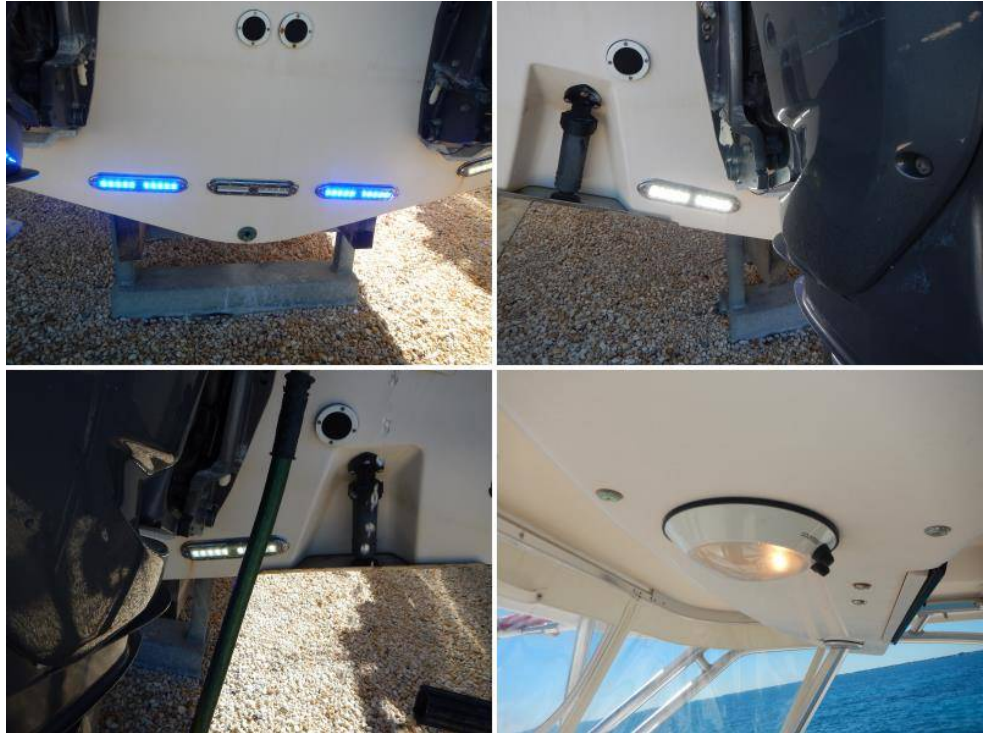
## Transom Underwater LED Lights

Blue and clear lights. All operational.

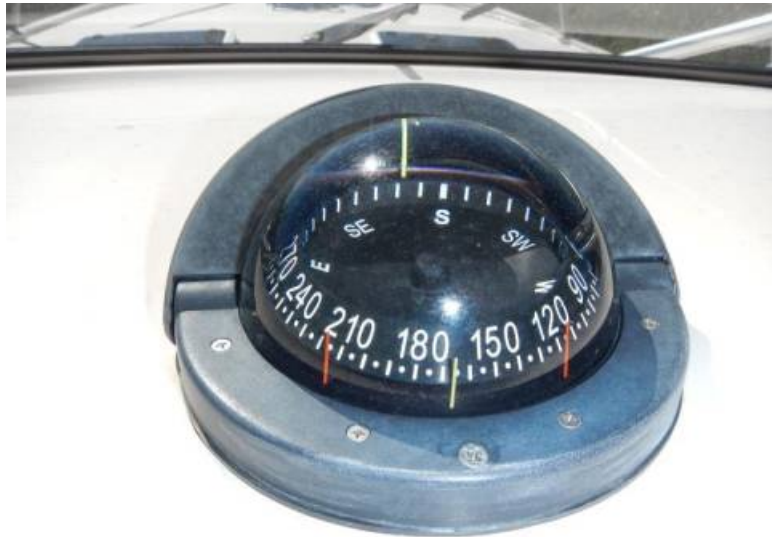
**Compass(es):**

4" Ritchie, Powerdamp, mounted on cockpit bulkhead, Appears functional.

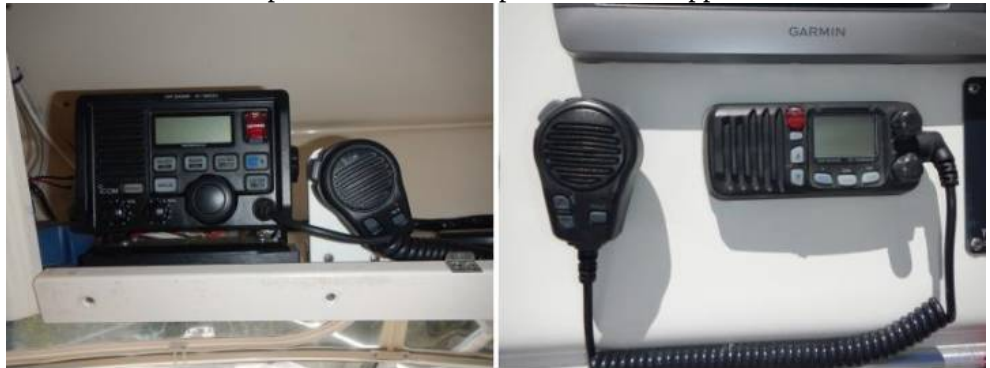
**VHF Radio(s):**

ICOM IC M-502 at the main helm and an ICOM M-402S on the flybridge. Both units powered up and sent and received communication.

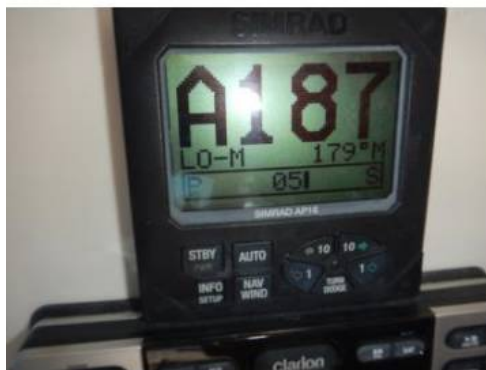
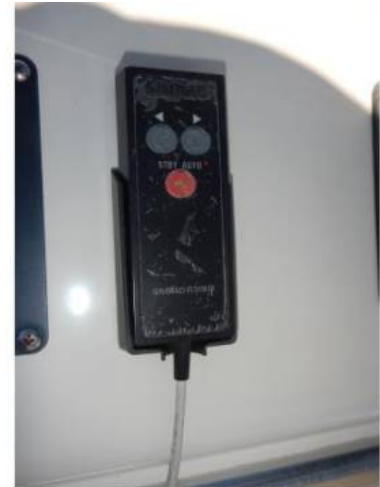
**Autopilot(s):**

SIMRAD AP16 on the main helm with a SIMRAD R3000X remote on the flybridge. Both units powered up and functioned during the sea trial.

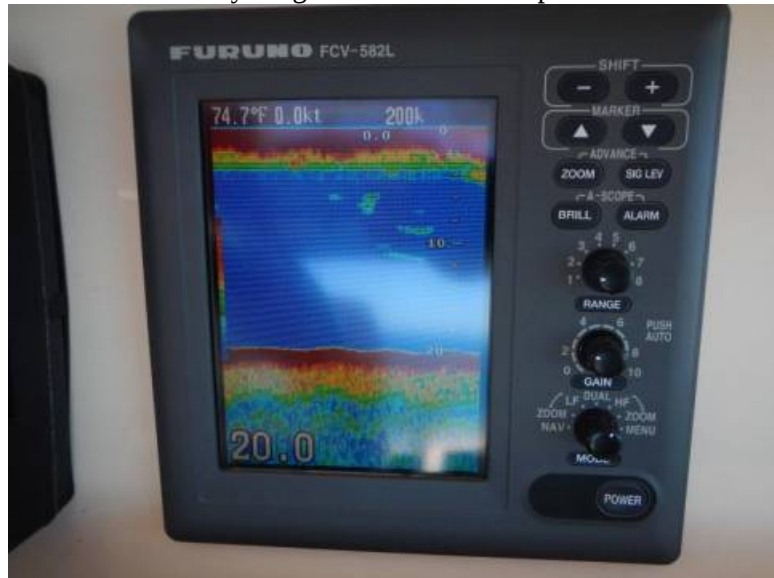
**Fish finder(s):**

Furuno FCV-582L at the main helm. Unit powers up and functioned during sea trial.

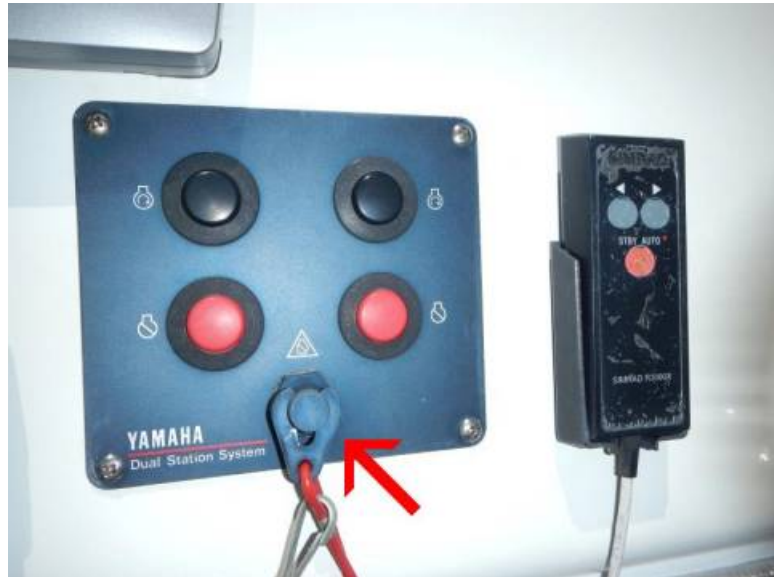
### Emergency Shutdown:

Emergency shutdown with lanyard available at helm position.

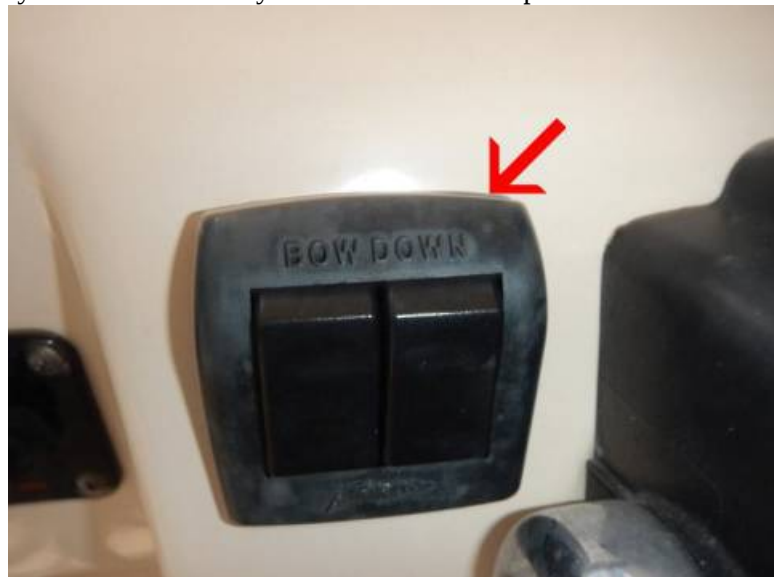
### Trim Tabs:

Trim tabs switches are operational and no leaks sighted.

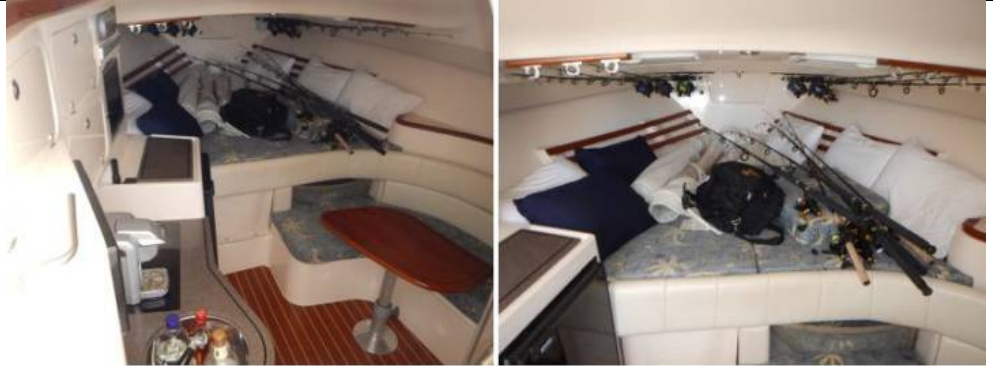
**Style:**

Traditional, Composite bulkhead material. Well secured. Clean and unmarred.

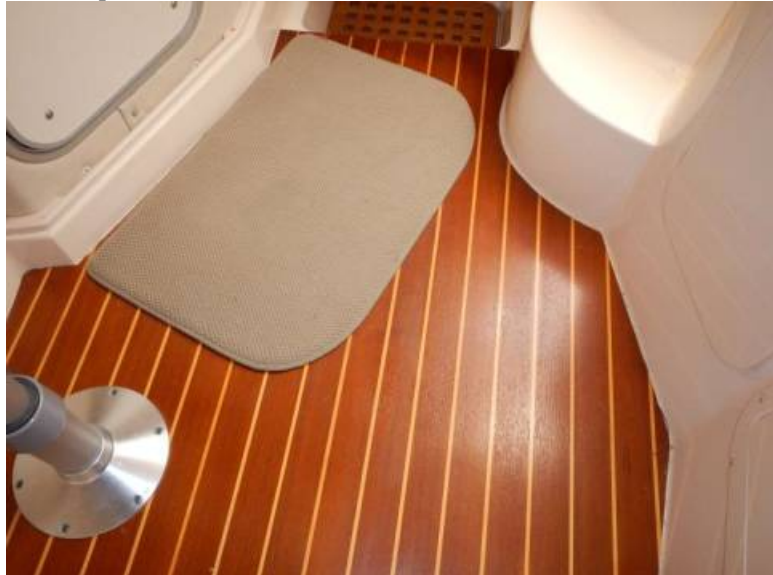
**Sole:**

Teak & holly cabin sole installed and is in good condition. Throw rugs have been placed in heavy traffic areas.

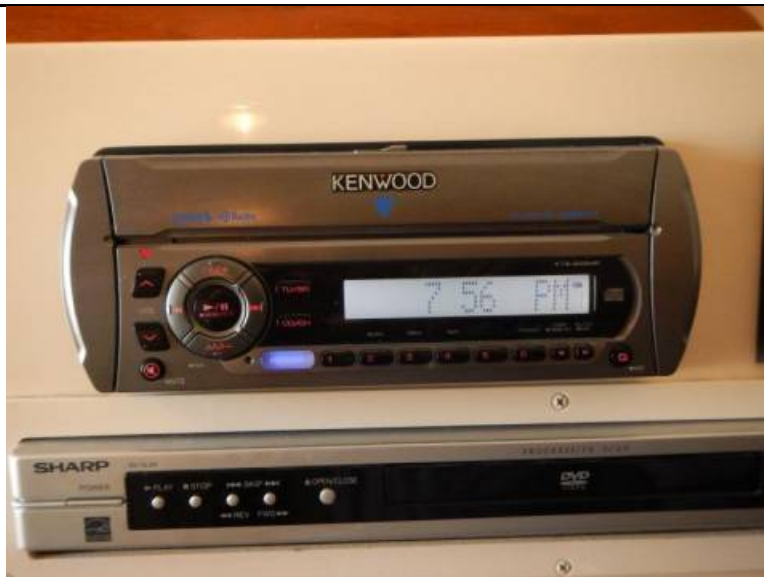
**Stereo(s):**

Main salon: Kenwood model KDC 2006 AM/FM/CD with satellite radio capability. Unit powered up when tested.

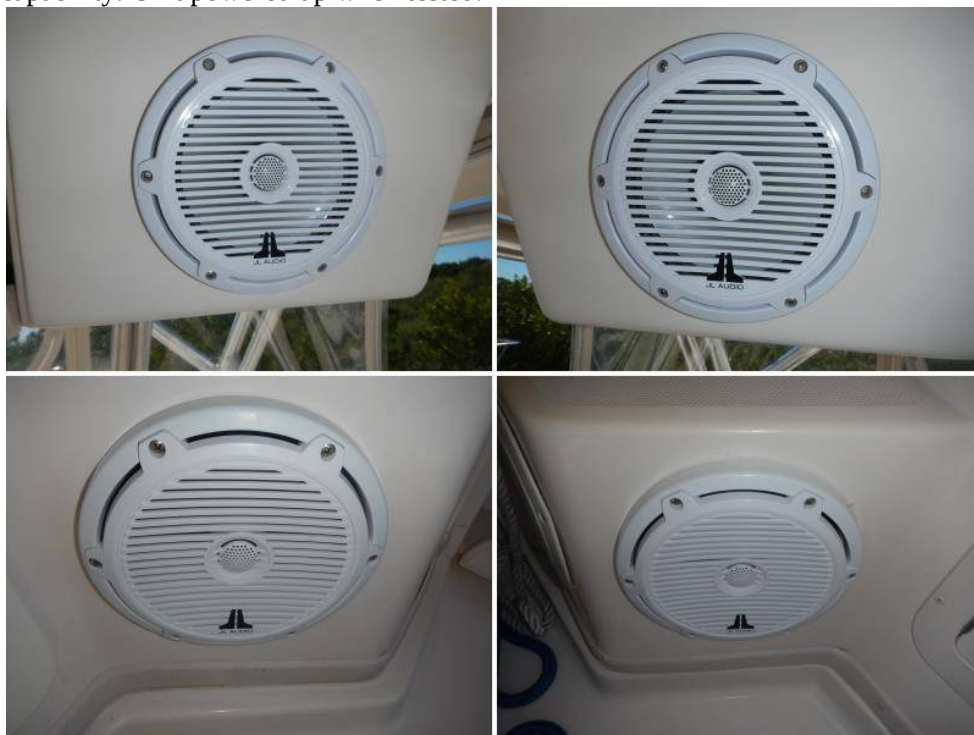
**Speaker(s):**

In Cockpit: JL Audio, All speakers powered up OK with the stereo. Sub Woofer powers up OK.

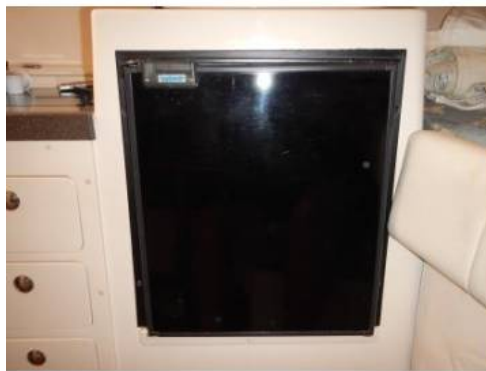
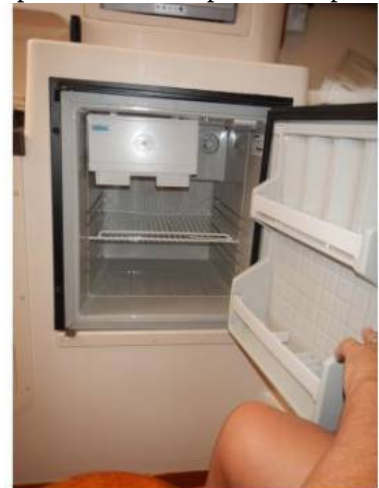
**Refrigeration:**

Upright, Isotherm Ice box available, Door safety lock is installed and functional. Pressurized hot and cold.

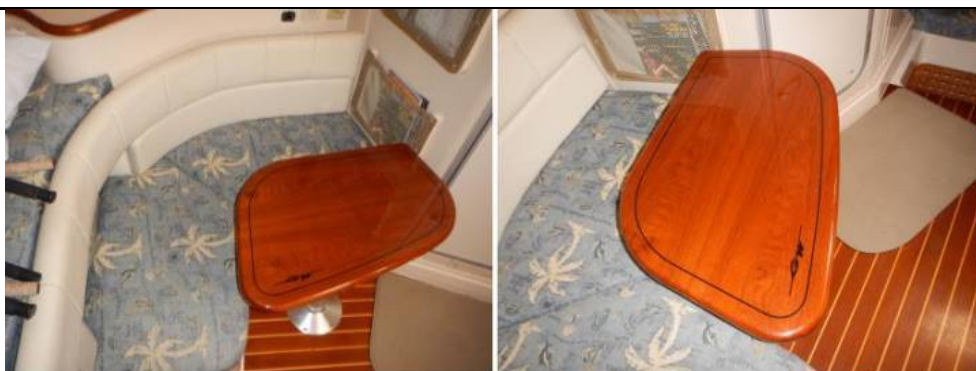
### Table type:

Cherry, Excellent condition.  
U-shaped seating around table.

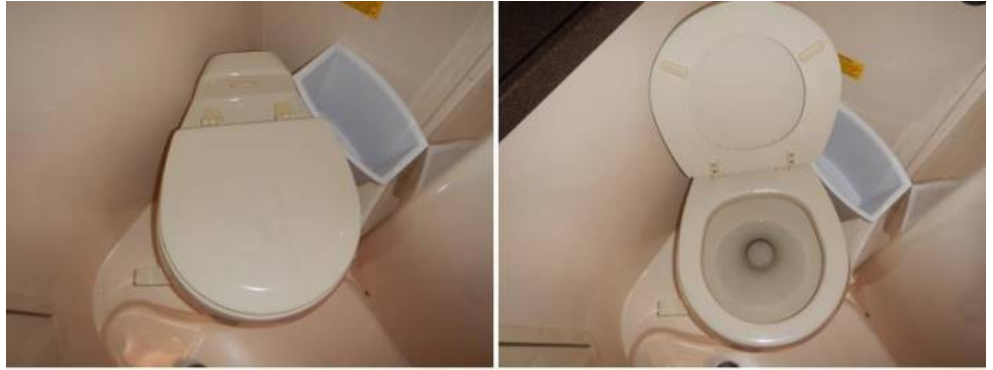
**Toilet(s):**

VacuFlush system, Powers up. No leaks sighted.  
Raw water intake thru bronze seacock. Hose secure.

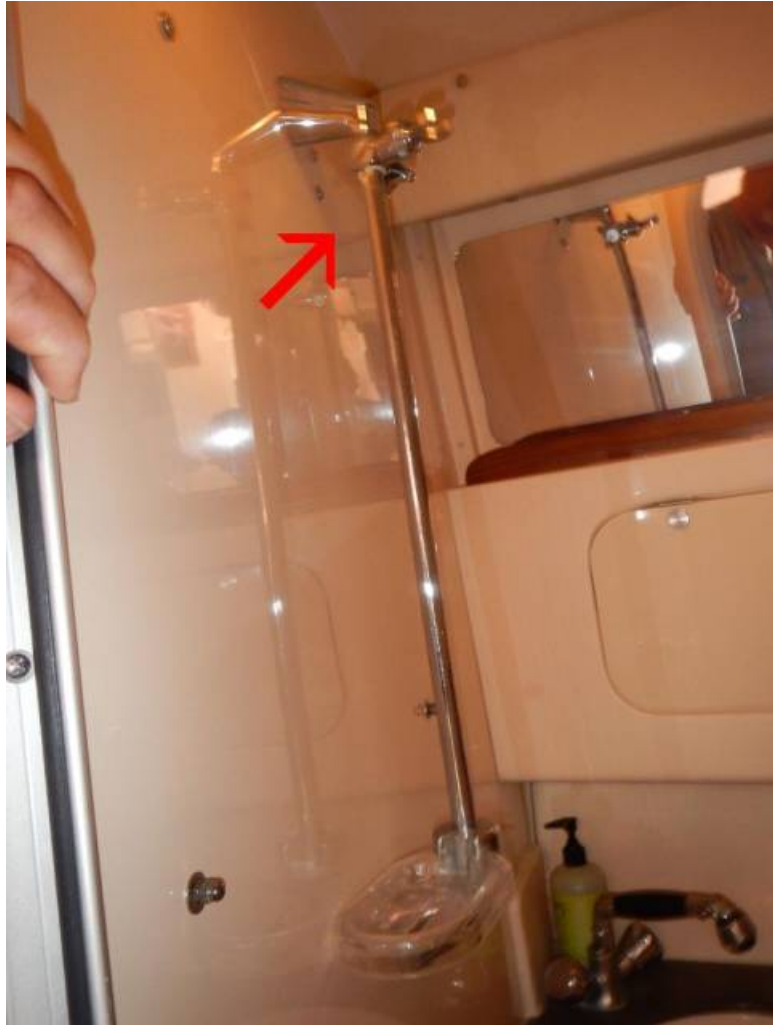
**Shower(s):**

Handheld fixture, Stand up stall.  
Functional.

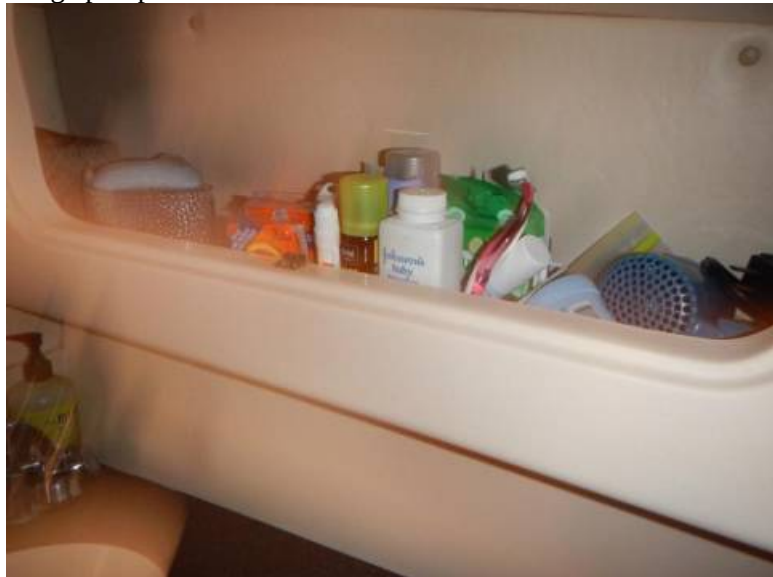
**Medicine Cabinet:**

Yes available and fully functional.

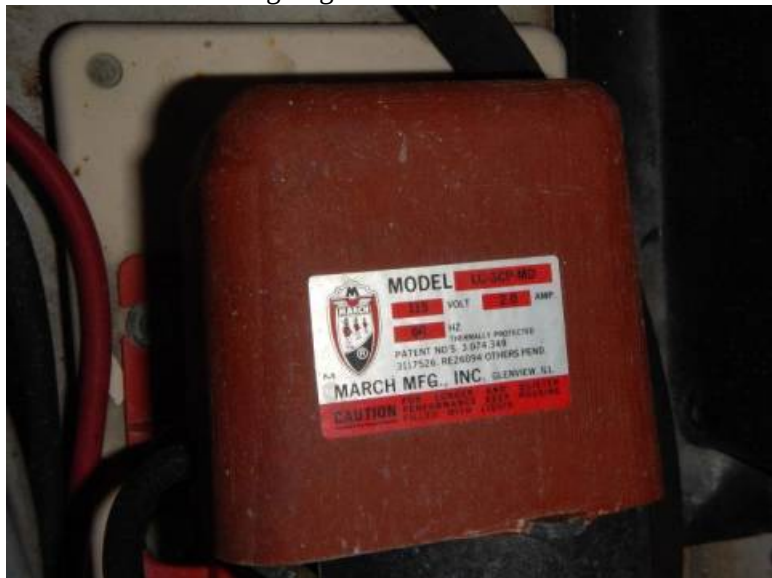
**Raw Water Cooling Pump:**

110 Volt pump functioned well when testing A/C units.

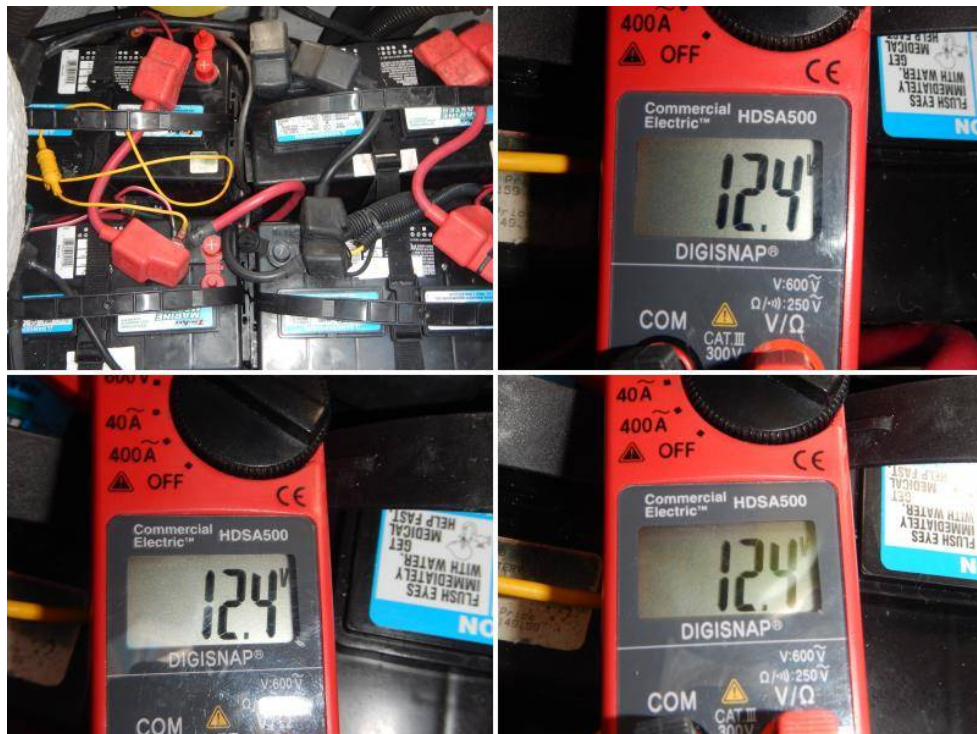
### Primary Batteries:

There are four batteries located in the side cockpit locker that are Group 27 Lead acid which provide service to the main engine(s) plus house electrical and are wired in parallel producing 12 volts. Batteries are well secured in boxes with straps or hold down brackets. Cables are properly color coded and positive terminals are properly covered with boots or box covers. All four batteries were charged.

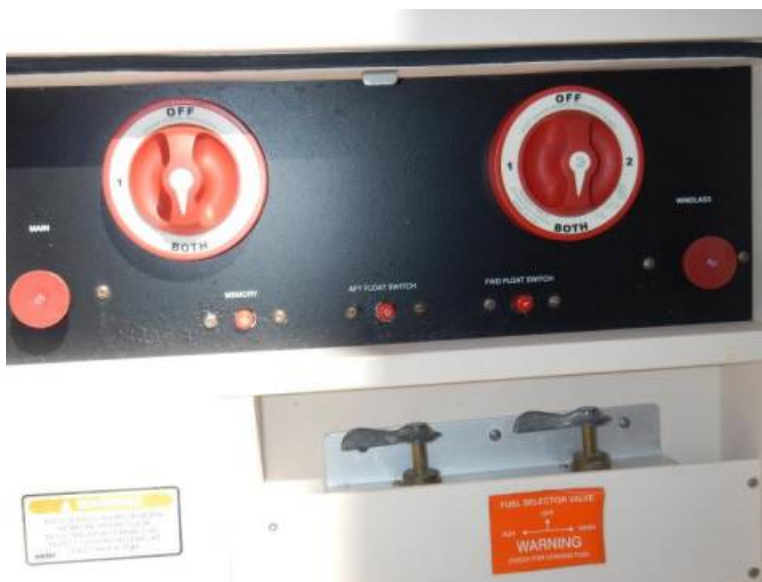
### Battery Selector Switch:

Yes Rotary switch is functional. NOTE: *Recommend alternating use of battery one and two when using vessel. Only use the battery switch All position if both batteries are low or when charging with battery charger/alternator.* Switched digital gauge to test battery condition.

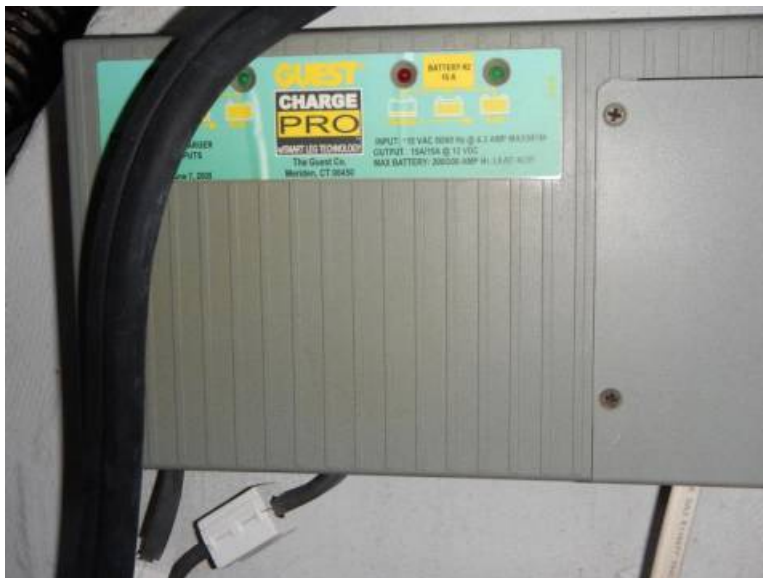
## Charging System:

Both engine alternators, plus the battery charger is a, -- Guest ChargePro, Charger is ignition protected. Functional.
