## **REPORT OF MARINE SURVEY**

**Pre-Purchase Condition & Value.**

**"Ricochet"**

**2006 Grady White 330 Express**

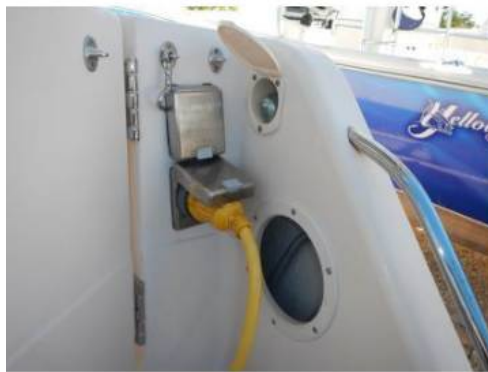
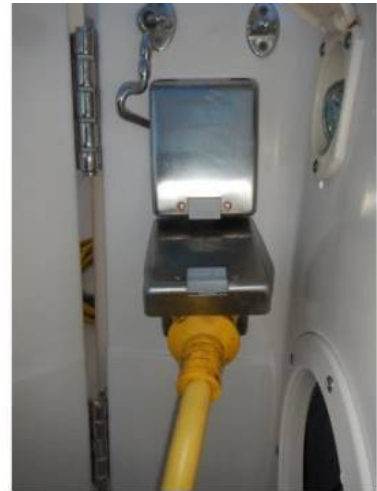
## A.C. Voltage System:

30 Amp - 120 Volt system. Shore Power: One inlet provided by Marinco 30 Amp capacity located on transom

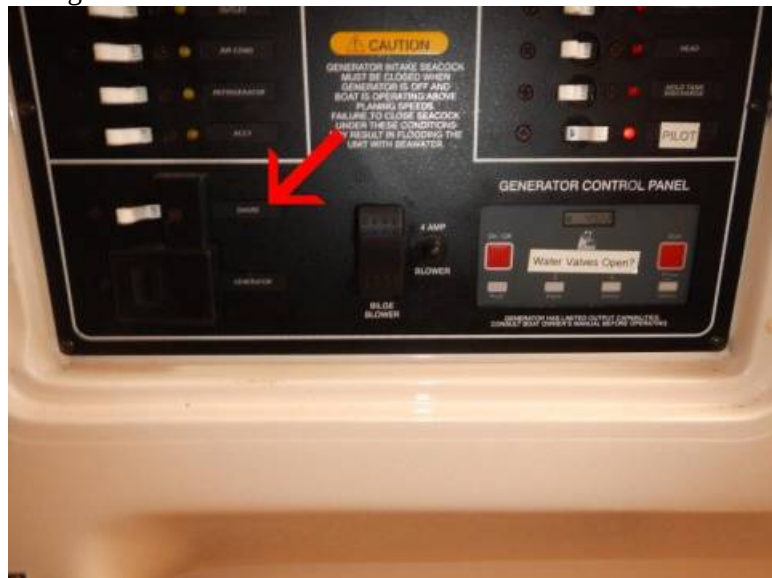
### Shore power breaker:

Dual pole breaker for shore power at main power distribution panel per ABYC recommendations.

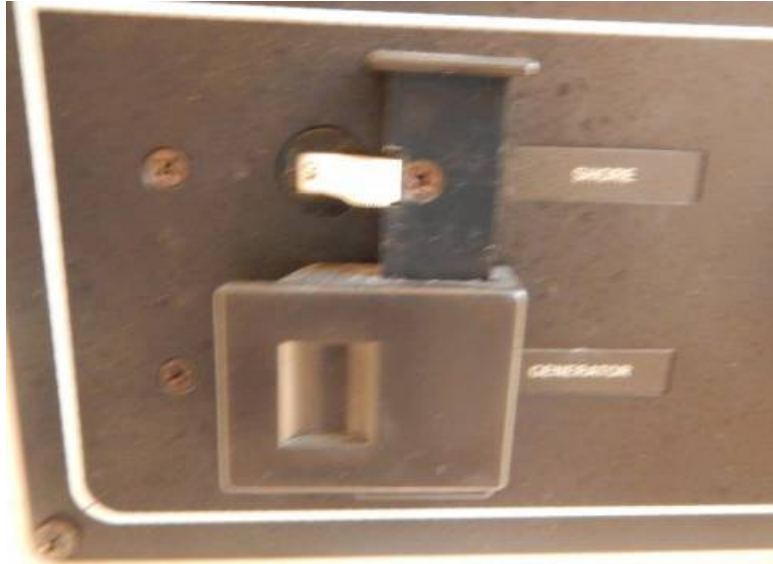
**A.C. Power Selector  
Switch:**

AC / Generator manual break/make lever switch located in main AC panel.

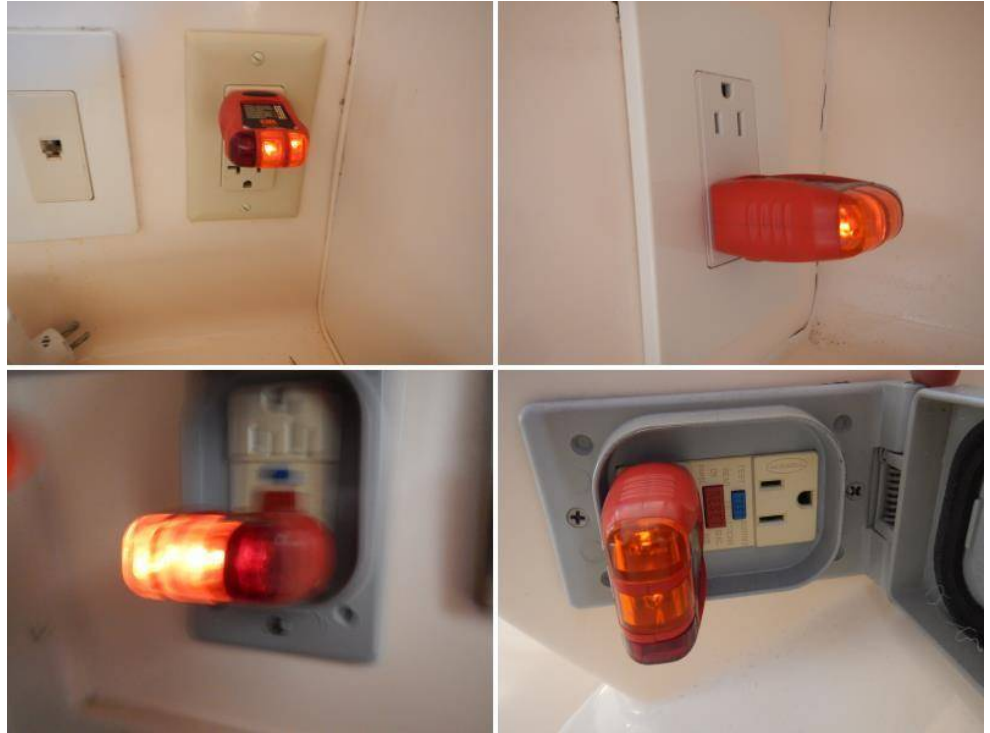
## GFCI Protection:

GFCI equipped 110V outlets have been installed in all wet locations. GFCI trips properly when tested in galley and head locations.

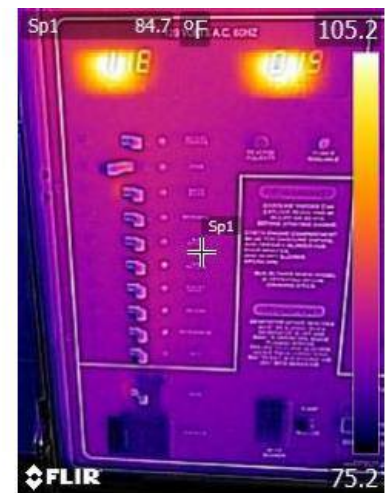
## Thermal Imaging

No anomalies were sighted when scanned with a FLIR thermal camera.  
Good Condition.

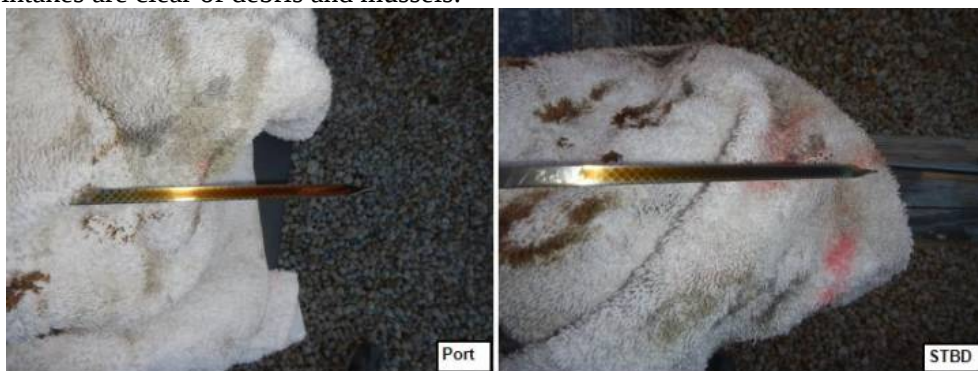
**Oil Level and Condition:**

Clean & full on dipstick for both engines.

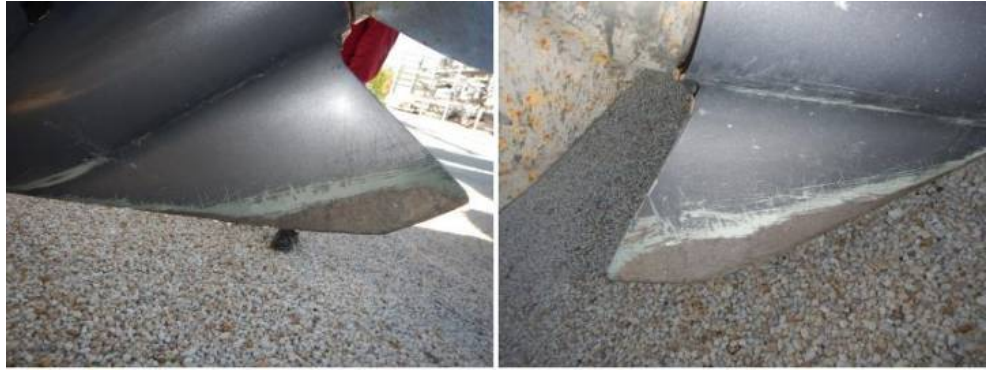
**Skeg Condition:**

Good condition. No chipped or damaged areas sighted.

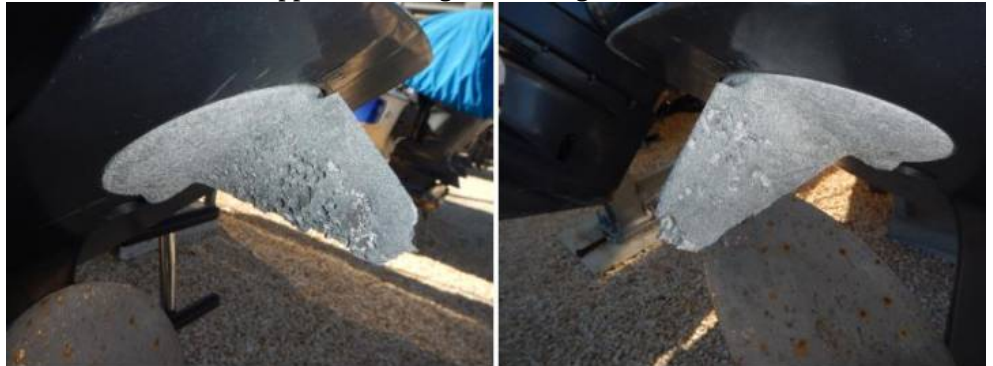
**Anodes:**

Good condition-remain serviceable. Monitor all anodes frequently and replace as necessary. Anodes are normal replacement items designed to protect the running gear from electrolysis. Keep spares aboard vessel.

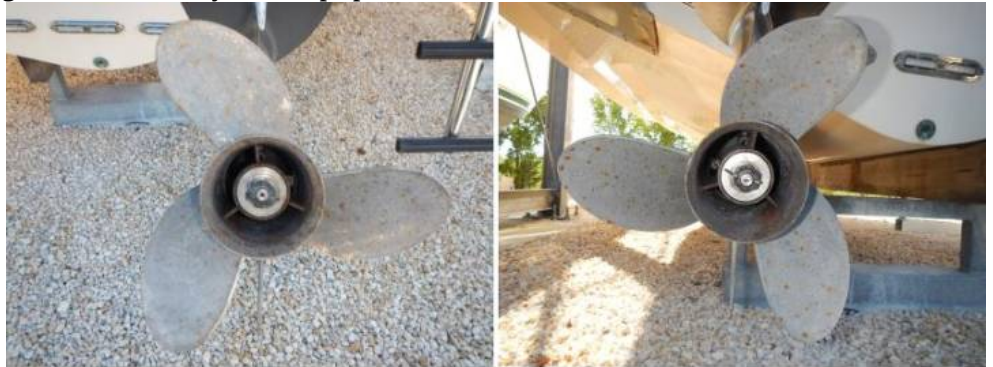
**Prop(s):**

three blades, stainless steel. Size: 19 x 15 1/4 Prop is in good condition with no cracks, corrosion or bent, nicked or chipped blades. Prop nut secure.

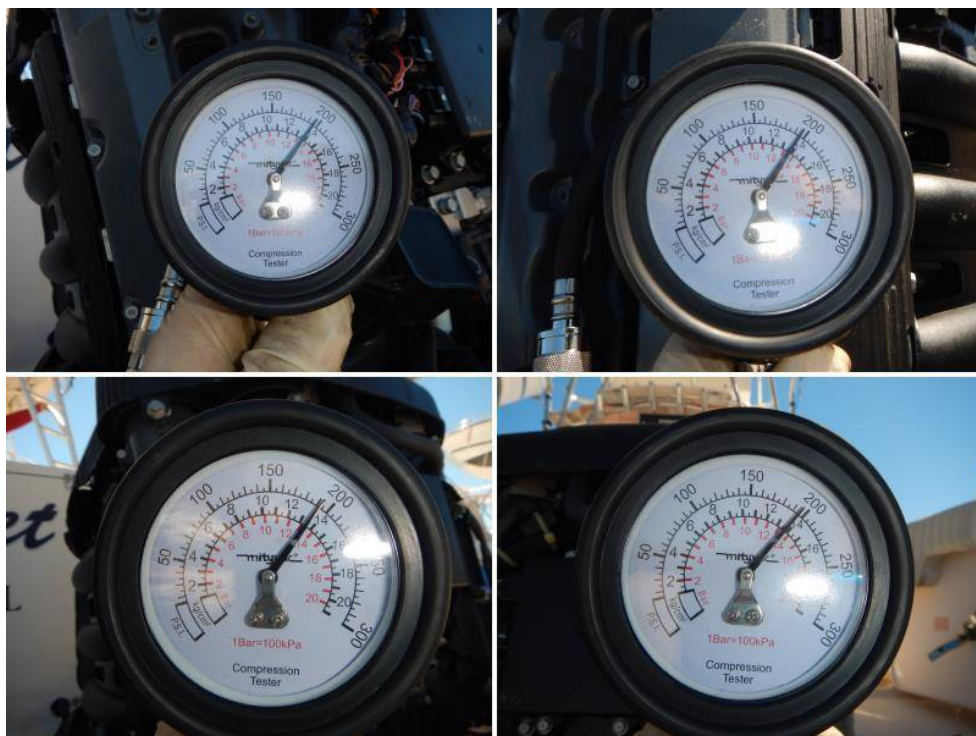
**Starboard Engine  
Compression Test:**

Cylinders 1-2-4 at 200 PSI and cylinder 3 at 199 PSI.

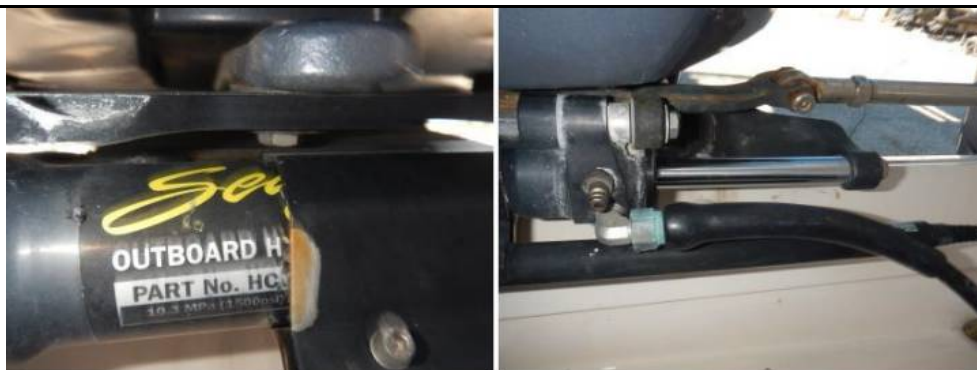
Type:

Sea Star-Teleflex, Hydraulic lines and ram cylinder with attached rudder tiller on rudder stock.

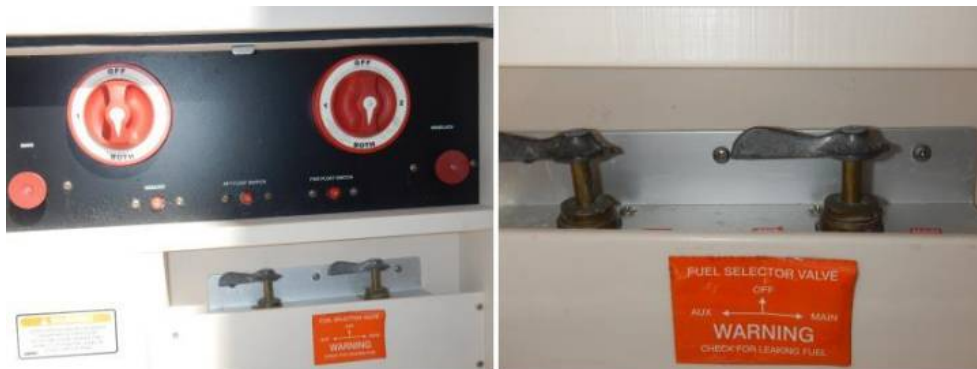
**Shut Off Valve(s):**

Ball valves at manifold are functional.  
Hose type, USCG A1 on hull sides.

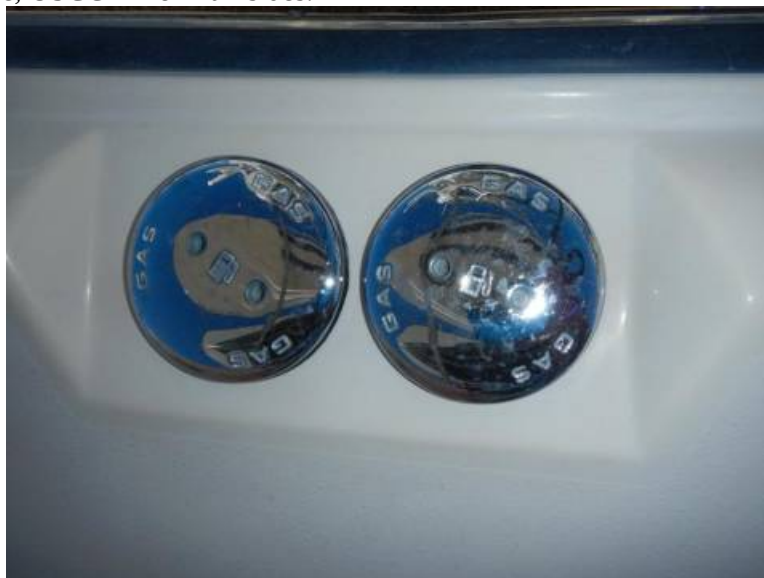
**Fill line(s) located:**

Side decks, clearly marked for gasoline fuel per ABYC recommendations.  
USCG Type A2 flex hose.

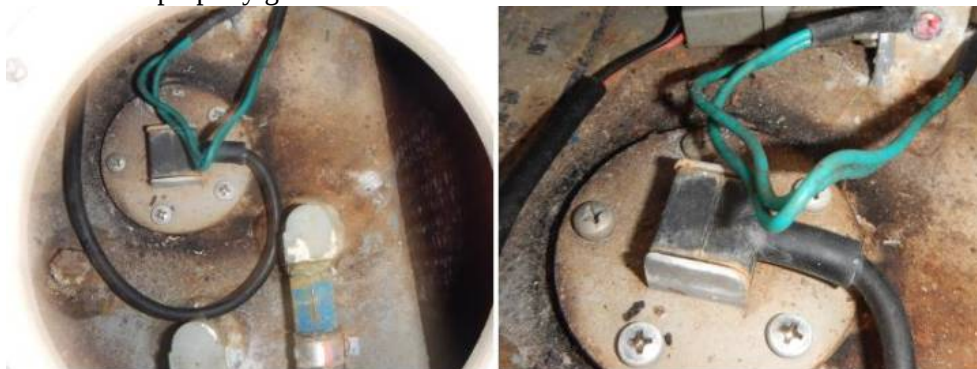
**Tank(s) grounded:**

Fuel fills are properly grounded to the fuel tanks.

Yes-Grounded properly.

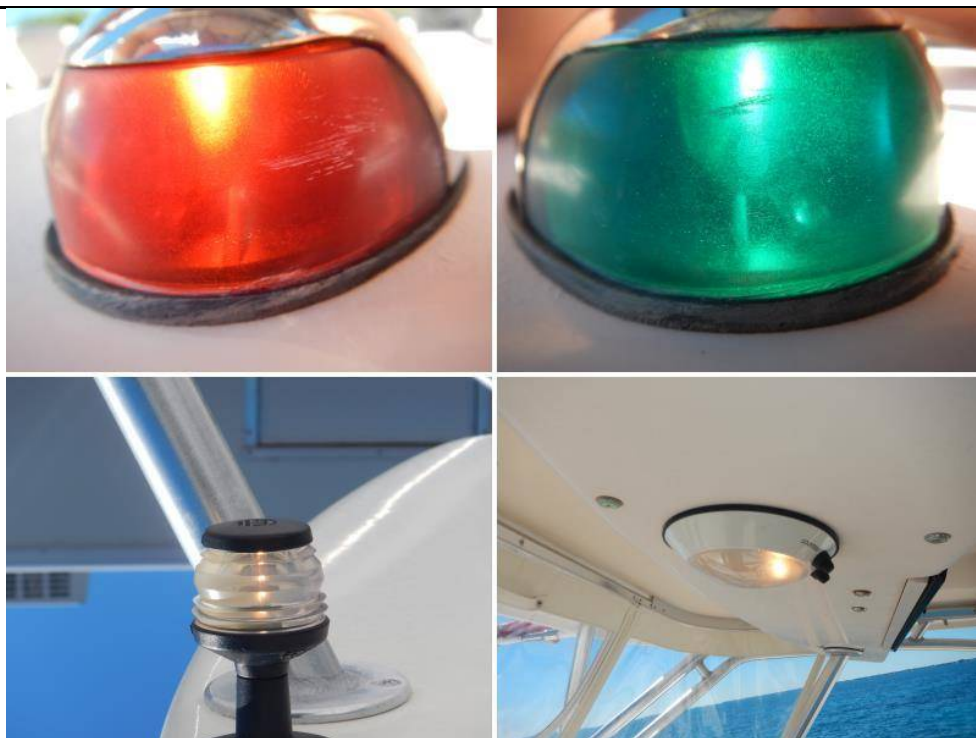
#### Navigation Lights:

All Navigation lights are fully operational.

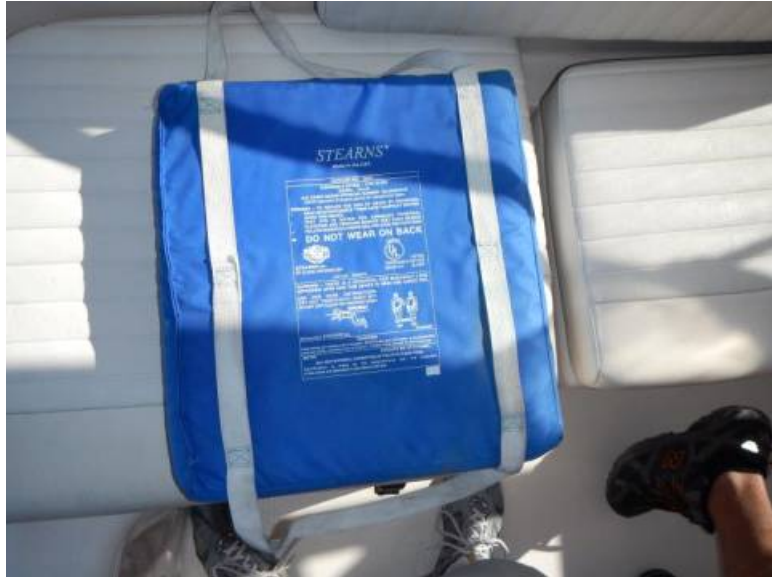
### Throwable Type PFD's:

The type of USCG approved throwable PFD devices sighted were: USCG approved buoyant cushion(s). All appear to be in good condition.

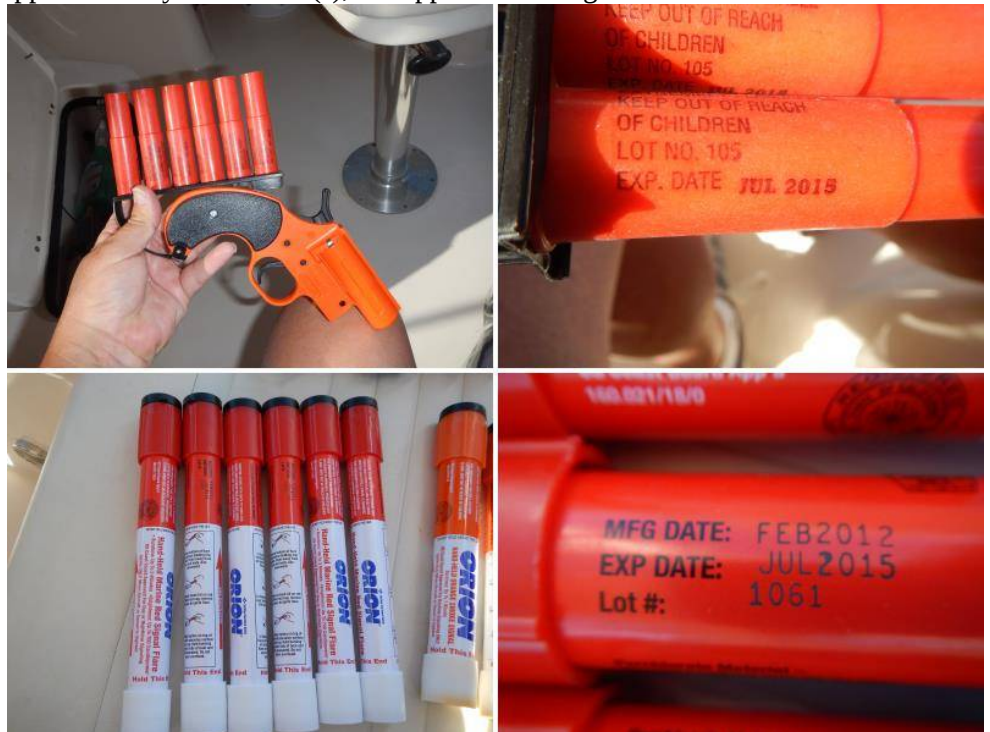
### Visual Distress Signals:

(2) 12 Ga Aerial with (10) cartridges. (10) Red hand held. Signals are current  
*NOTE: All visual distress signals have a printed expiration date- 3 years from date of manufacture. It is recommended that expired signals be retained for backup. You must have at least three aerial or three red hand held signals that are current.*

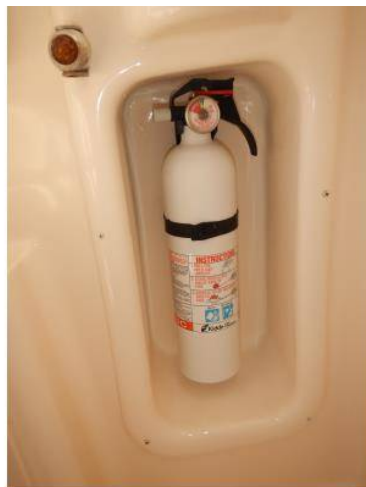
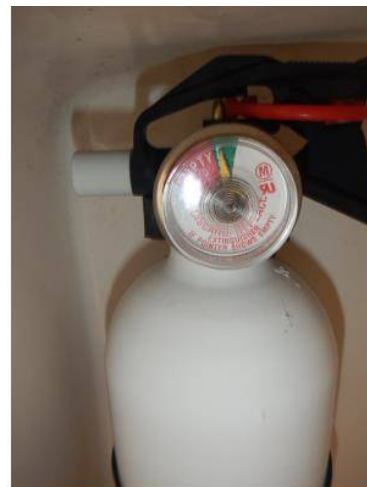
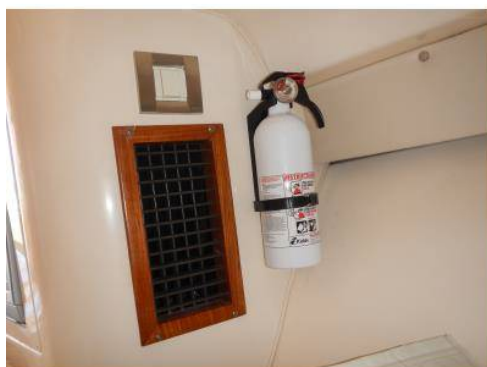
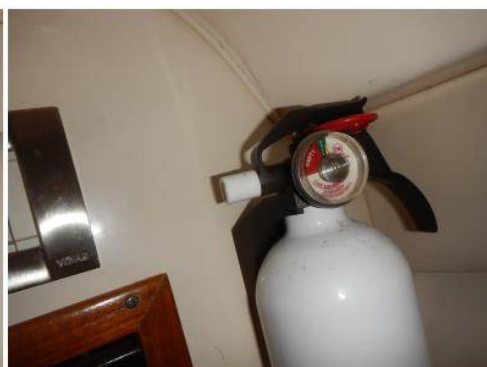
## Dry Chemical Size II:

Two USCG approved USCG approved extinguisher(s) sighted at the following locations: Cockpit and cuddy cabin. All gauge(s) read full.

Fire extinguisher equipment sighted complies only with minimum USCG regulations.----- USCG standards for vessels 26 to 40 feet require two (2) BI extinguishers or one (1) BI and (1) one Fixed system. ABYC A4.6.3 and NFPA 10.2.1 recommend three (3) extinguishers: one(1) outside the engine compartment, One at steering position and One near the galley or passenger cockpit. Recommend compliance with ABYC and NFPA for this size vessel.

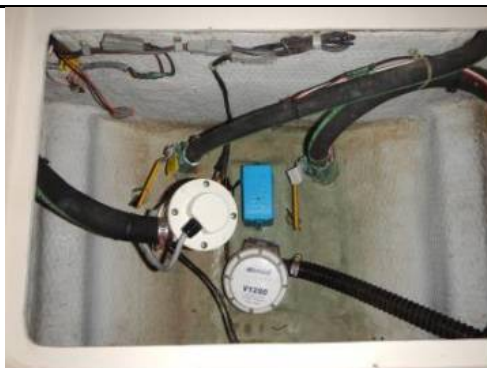
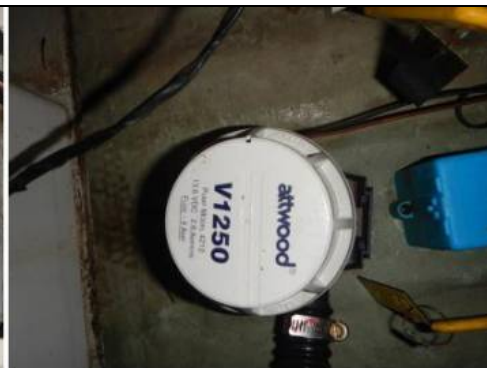
### ELECTRIC PUMPS:

One electric pump. Located at: Midship / Central bilge, Attwood 12 volt, 1250 GPH with automatic float switch. Pump powers up when switched on manually.

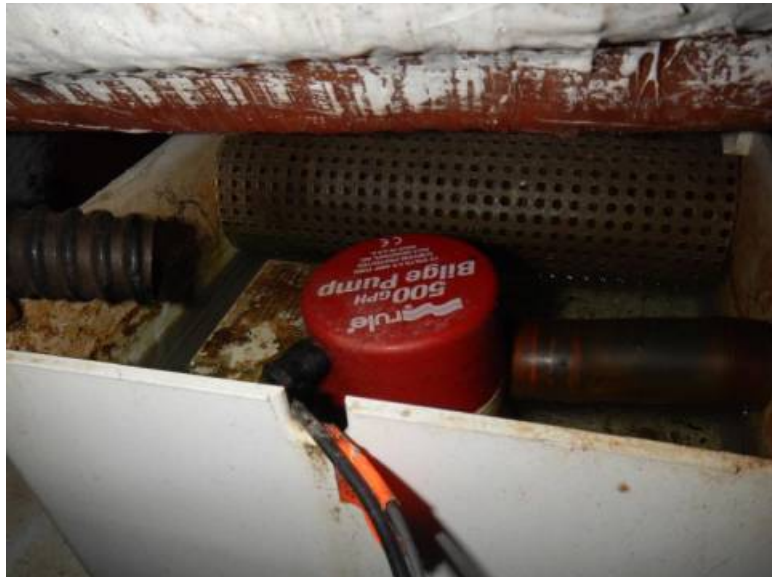
## SHOWER & SUMP PUMP(S):

One pump. Rule 500 pump in sump.

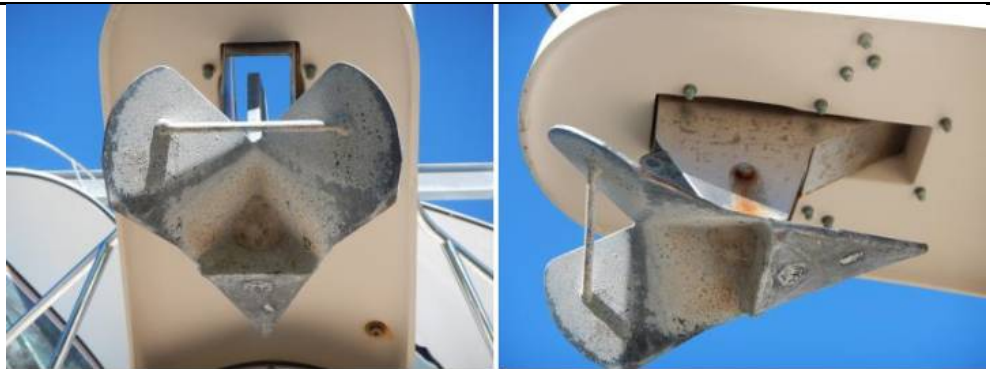
### Primary anchor:

Plow type, Sized: #22 with undetermined length of raw chain 7/16" anchor line, Anchor/rode shackle pins are all properly seized.

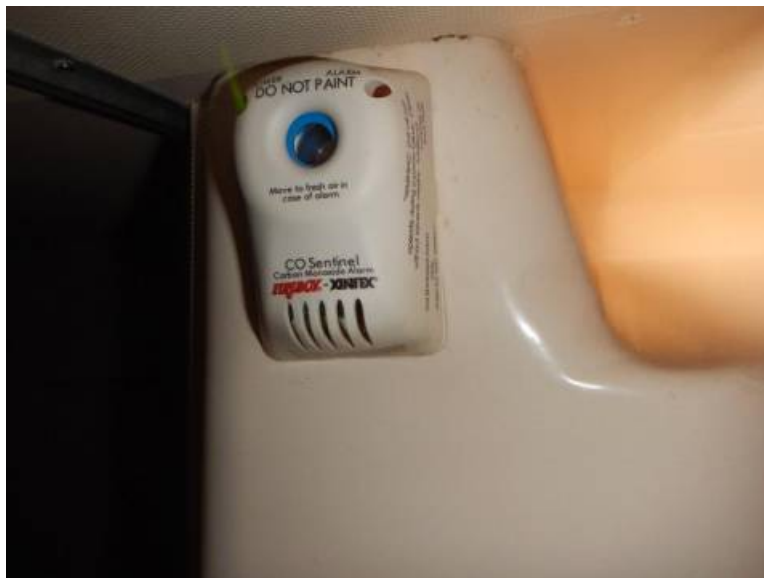
**Carbon Monoxide  
Detectors:**

Fireboy XINTEX Carbon Monoxide detector CMD-3M, Tests OK. *NOTE: During the burning of any of fuels, Carbon Monoxide ( CO ) gas may be created due to incomplete combustion from propulsion systems, cabin heater or stove as well as nearby boats running generators. Adequate ventilation must be provided at all times while burning any of these fuels, but CO may also be drawn into the cabin through ventilation systems. This is especially true of boats running air conditioning. CO is a silent menace and kills without warning, Regular testing of installed CO detectors in any occupied spaces below decks is highly recommended.*

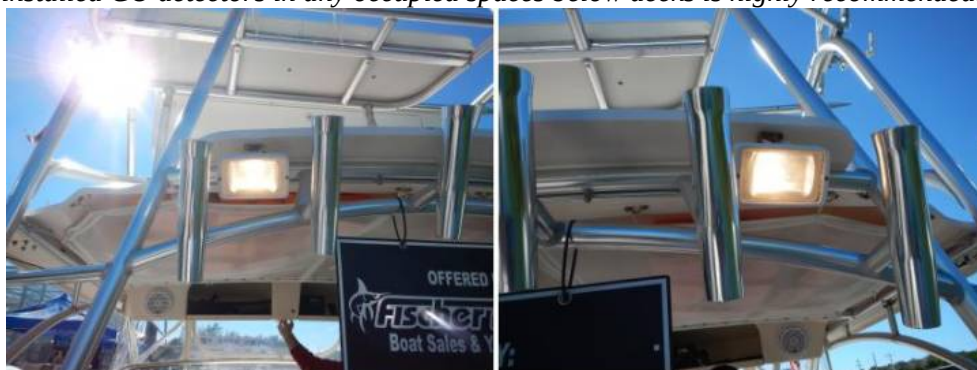
**Deck spreader lights:**

Yes.
